Arborist Report

ALBANY HILL EUCALYPTUS TREE SURVEY

DATE: July 23, 2021

SBCA TREE CONSULTING

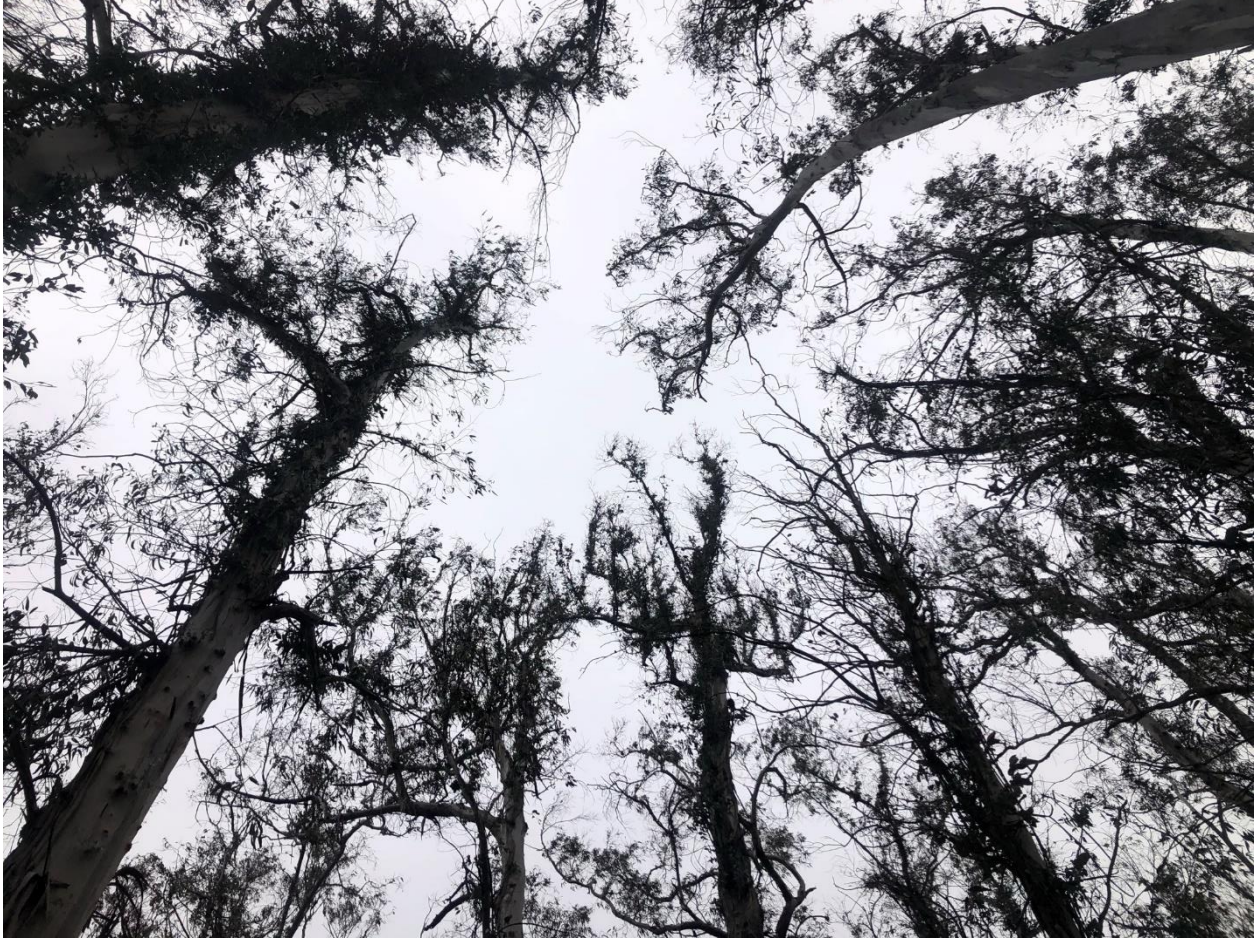
Photo 1. Photo above shows the tops of the Eucalyptus located in the EGHT area at the northwestern end of the park. Trees in this area were observed to be in the worst condition, with significant fire scars, dead tops, and live crown ratios less than 10%.

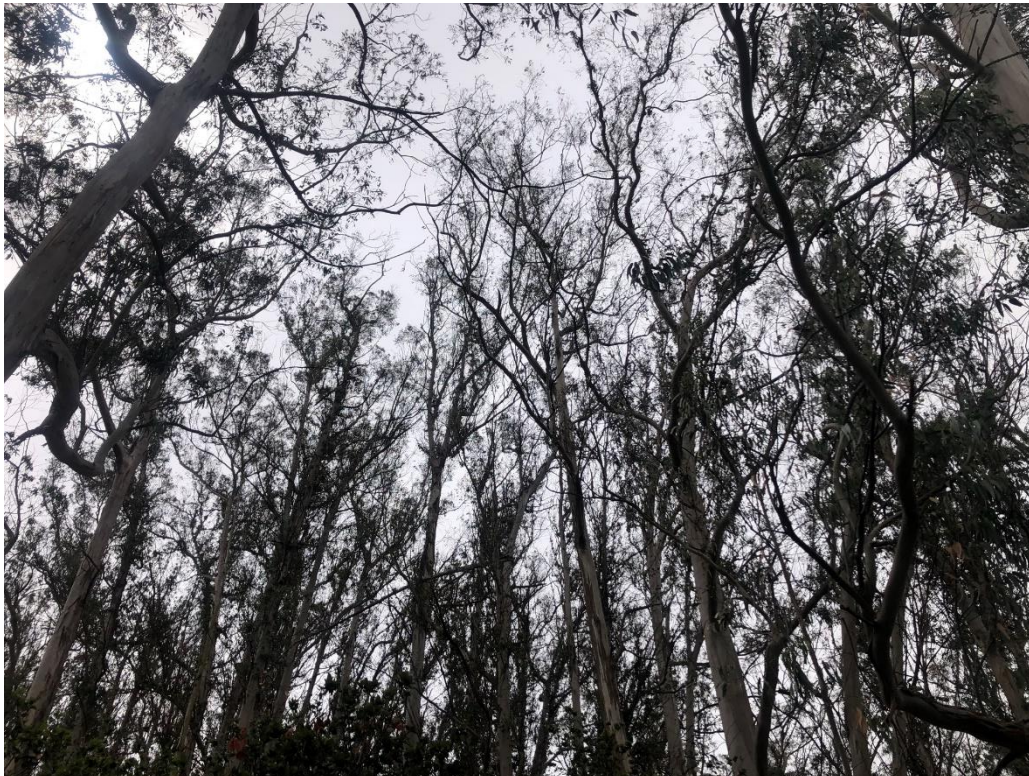
Photo 2. Photo left shows the condition of trees in the EHTH area, between the trail and Taft. Trees have very little leaf cover to support their system due to the drought and fungal leaf infection(s).

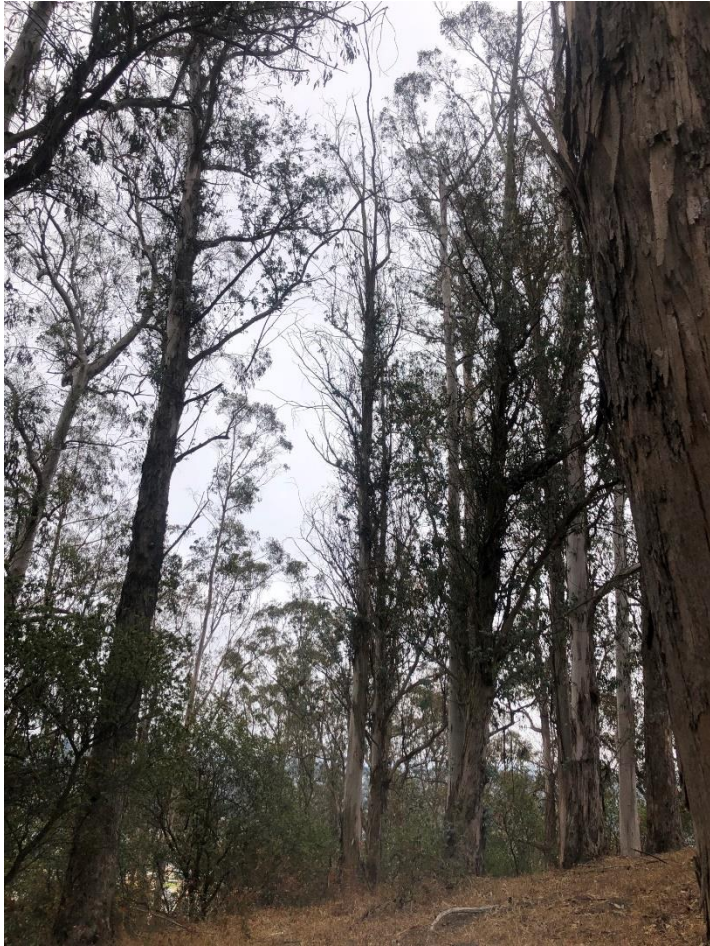
Photo 3. *Photo left shows tree #17 in the middle, with a health condition rated as Poor-Dead. The top is noticeably dead.*

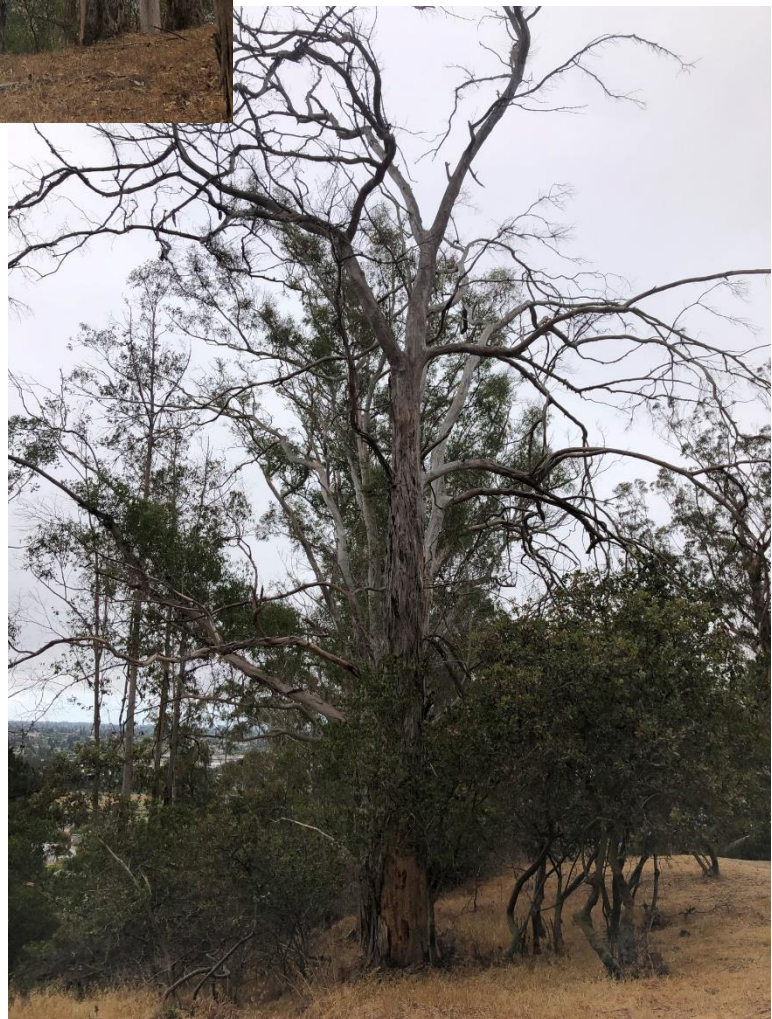
Photo 4. *Photo right shows dead tree #181. Trees located at the top of the hill are in worse condition than those at the bottom, likely due to less moisture availability.*

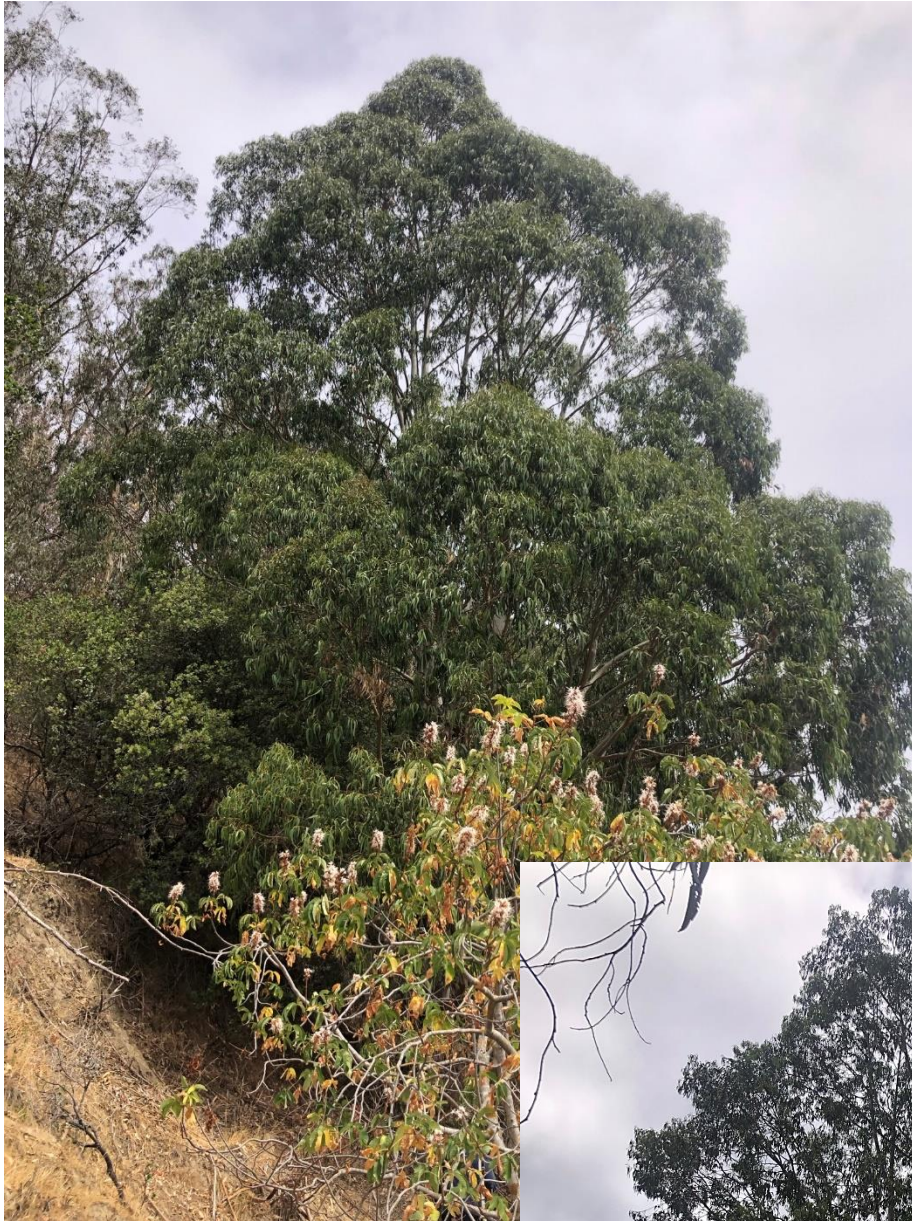
Photo 5. Photo left shows a very healthy Eucalyptus located along Jackson St. Trees in this area get less sun and wind (which means less evapotranspiration) and more water due to their location on the north side of the hill.

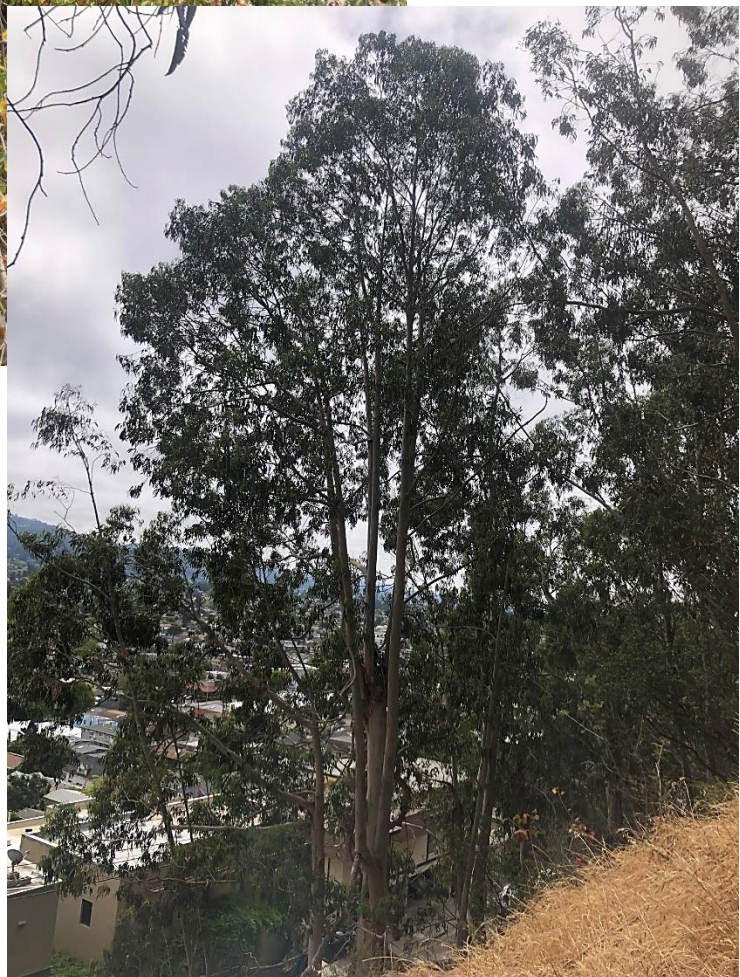
Photo 6. Another tree along Jackson appearing in Good health. Unfortunately, these trees are located on a slope and there are concerns related to root stabilization. Removal is recommended for all such trees.

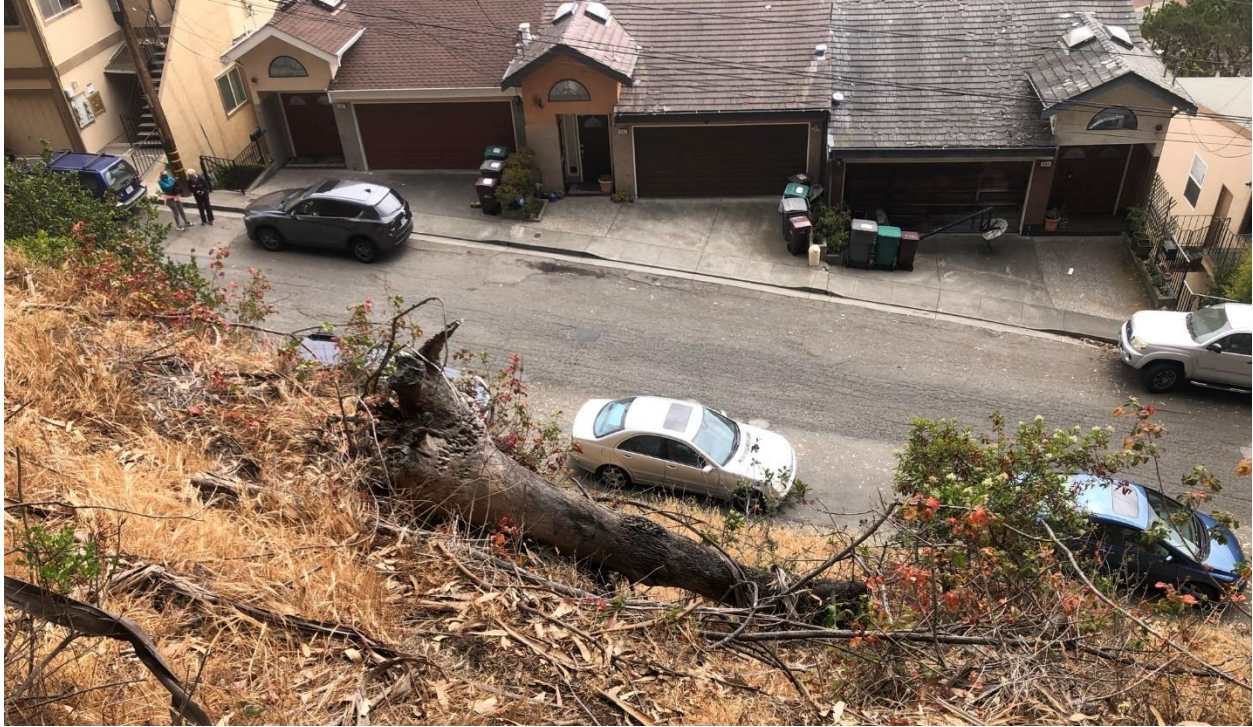
Photo 10. *Photo above shows another downed tree on the slope above Taft.*

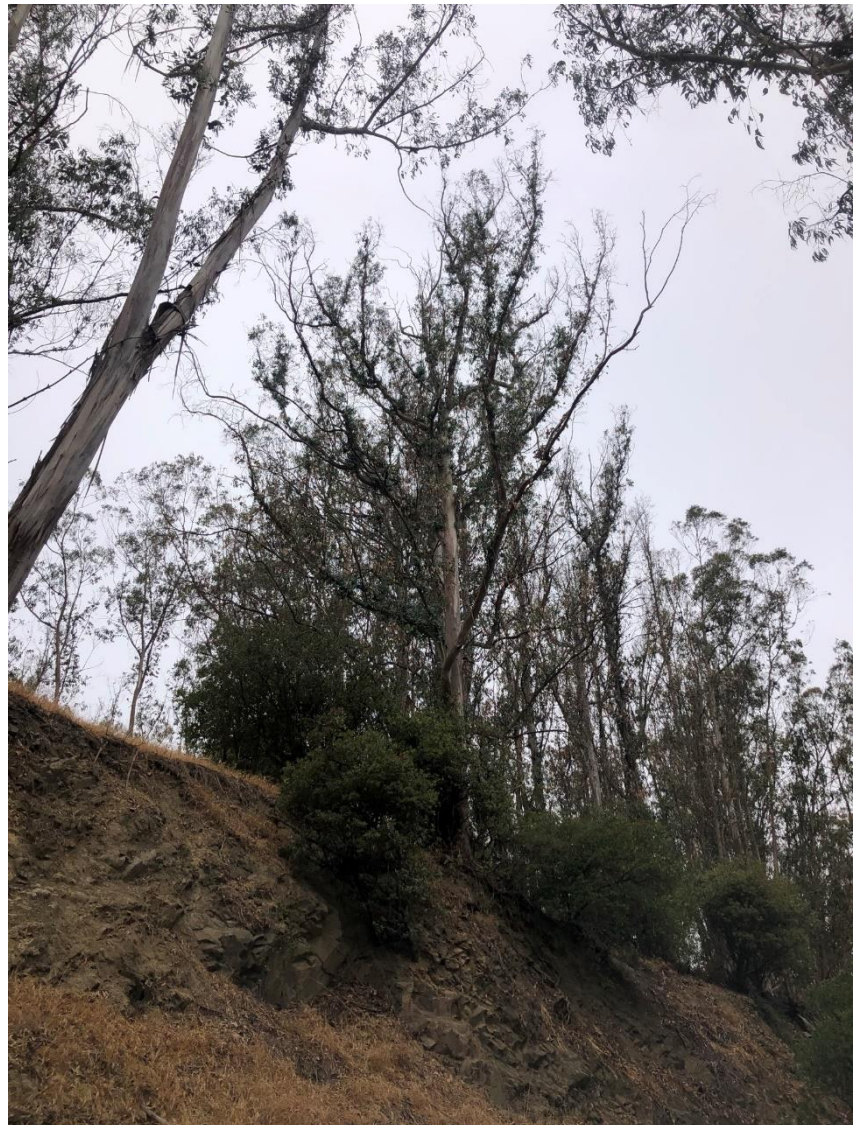
Photo 11. *Photo right shows a tree in poor health condition at the edge of the slope. There is a higher risk associated with this tree due to the road and residences below.*

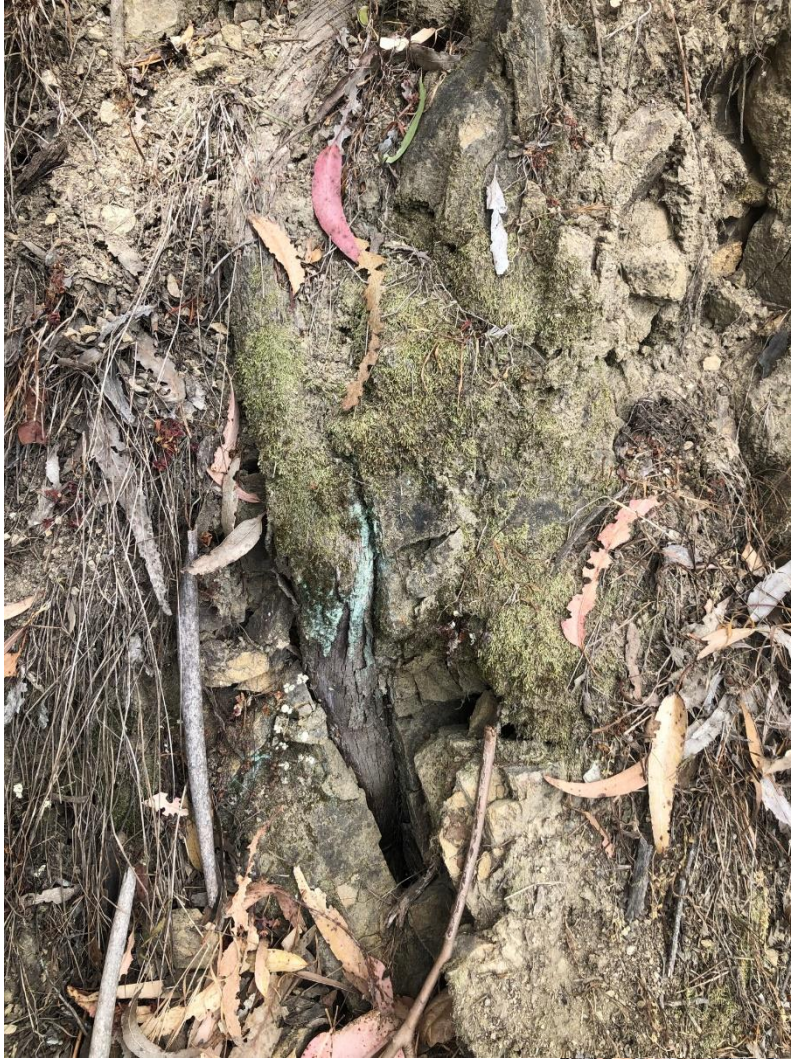
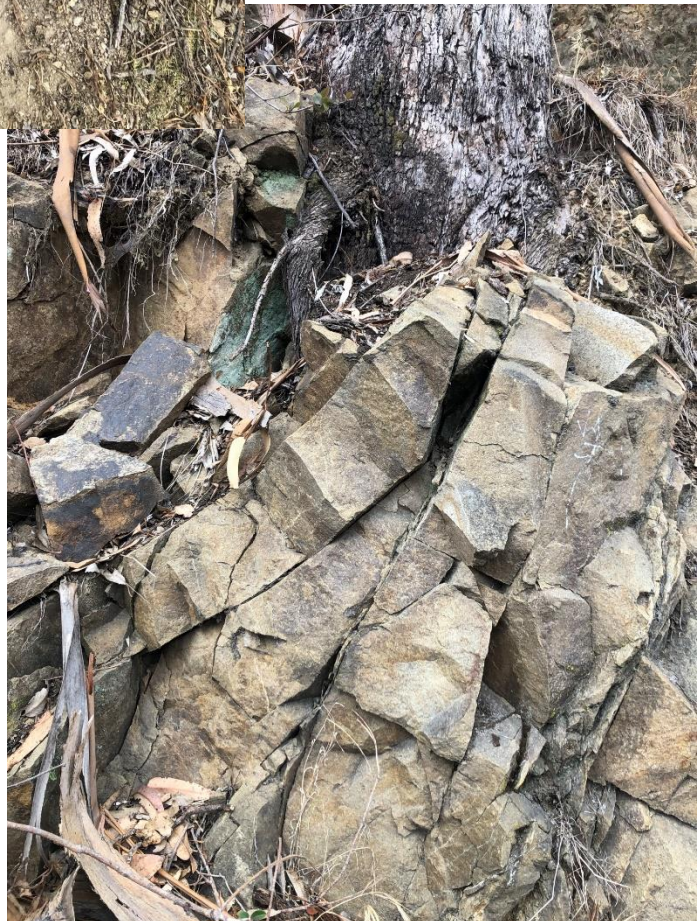
Photos 12 and 13. *Photos on this page show examples of how roots can work to loosen sandstone by forcing themselves between cracks and expanding. Windforces also create root movement which loosens soil. Trees do not work to stabilize slopes. In fact, it is just the opposite.*

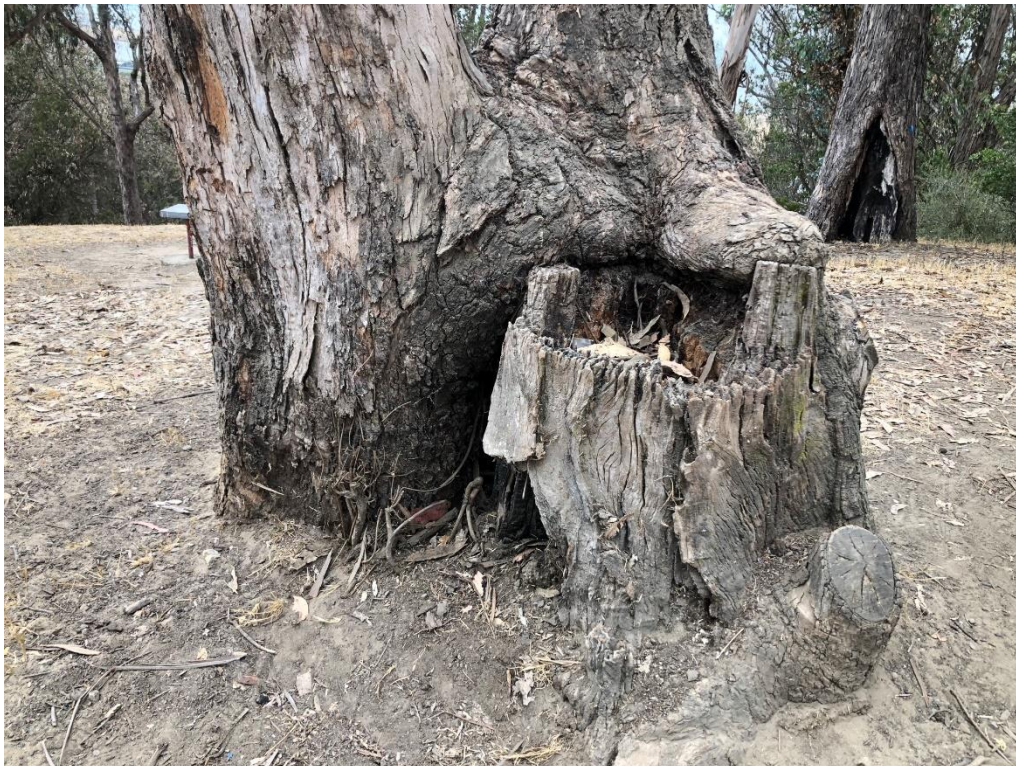
Photo 15. Photo left shows the base of tree #359. This tree was previously cut down, and the stub sprouts emanating from the cut trunk were allowed to grow large again. As the old trunk decays, the stability of the tree will become an issue.

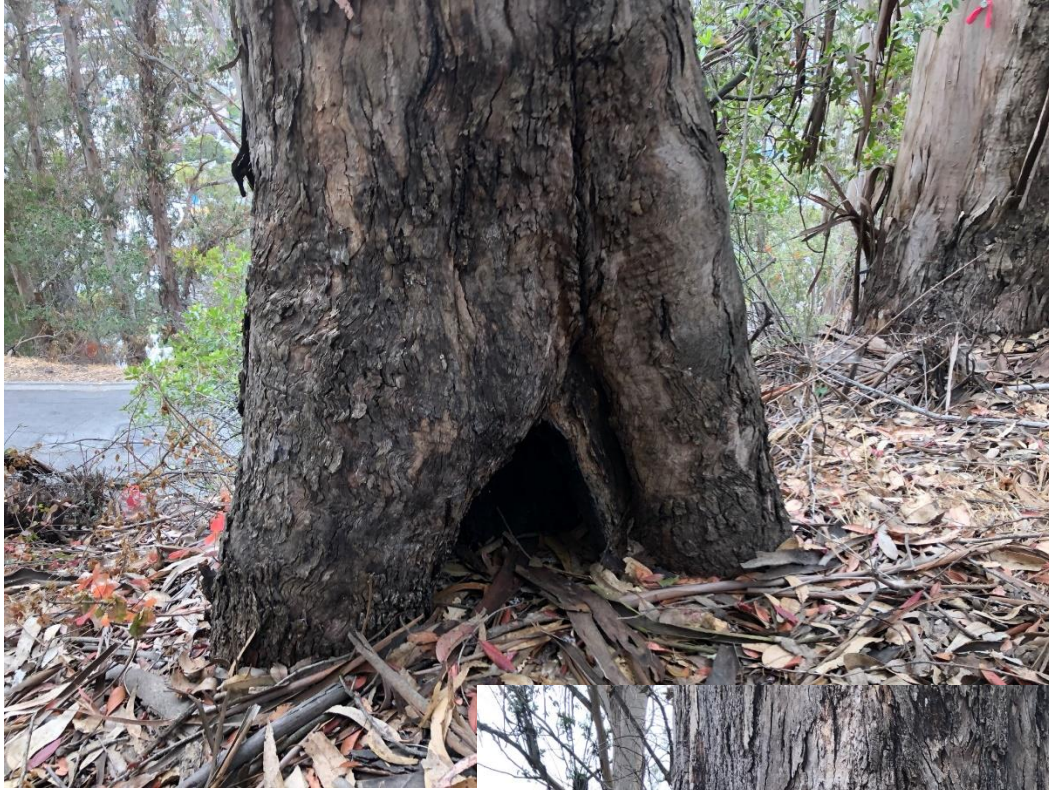
Photo 16.
Photo left shows the fire scar at the base of tree #100.

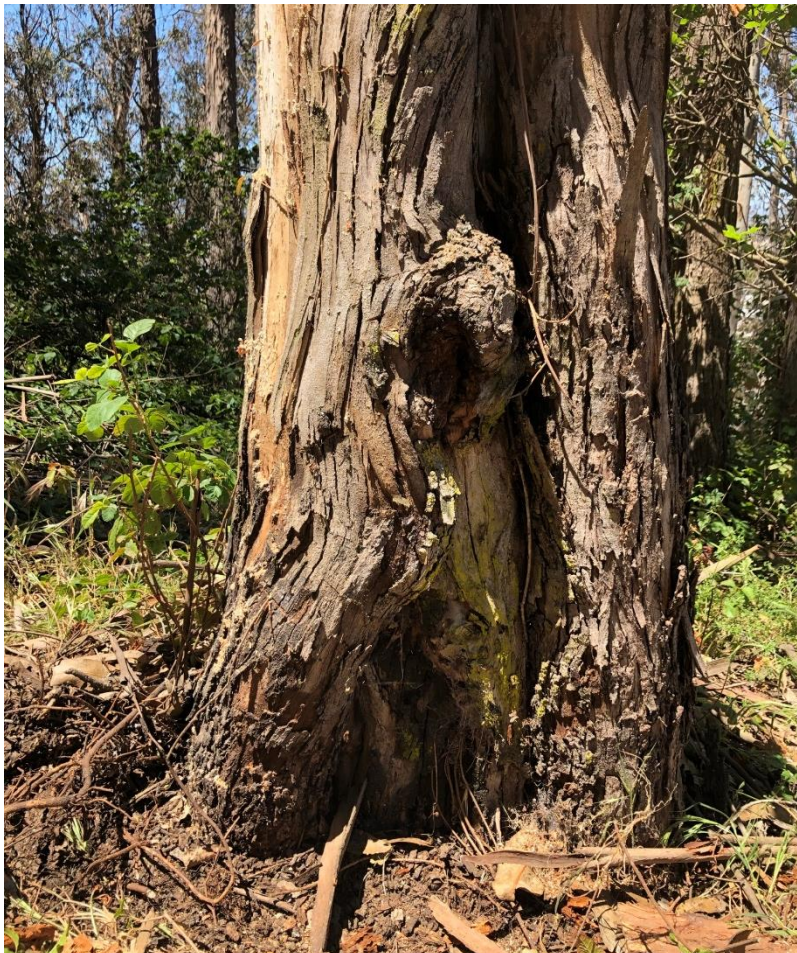
Photo 19. *Photo left shows the fire scar at the base of above tree. This raised concerns regarding all trees with fire scars and potential for significant hollowness. All trees with fire scars are recommended for removal. If there is a desire to retain such a tree, a Level 3 Risk Assessment must be performed.*

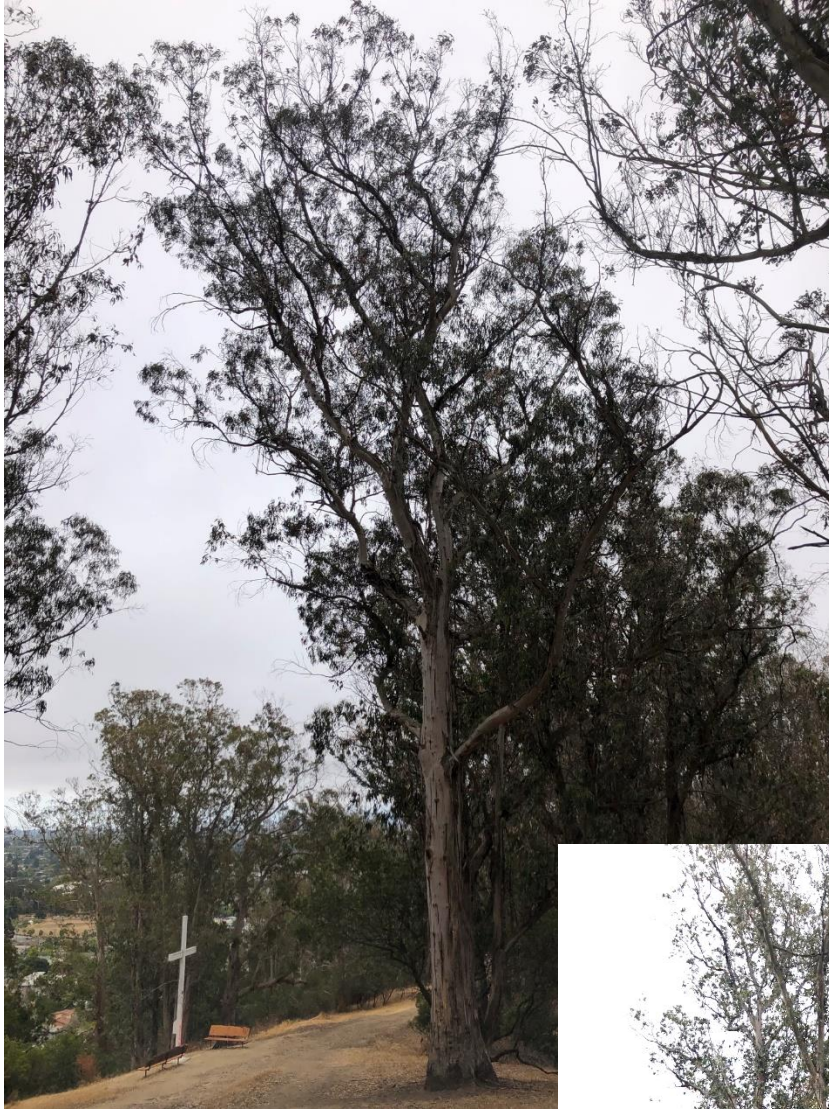
Photo 20. Photo left shows tree #249 in the ESHT area. This tree was given a “2” for Live Crown Ratio, meaning it has 10-50% of the total foliage a healthy tree of its size would have. The tree was recommended for pruning to remove dead wood over the path. If there is a desire to retain this tree, mulching and supplemental irrigation is recommended.

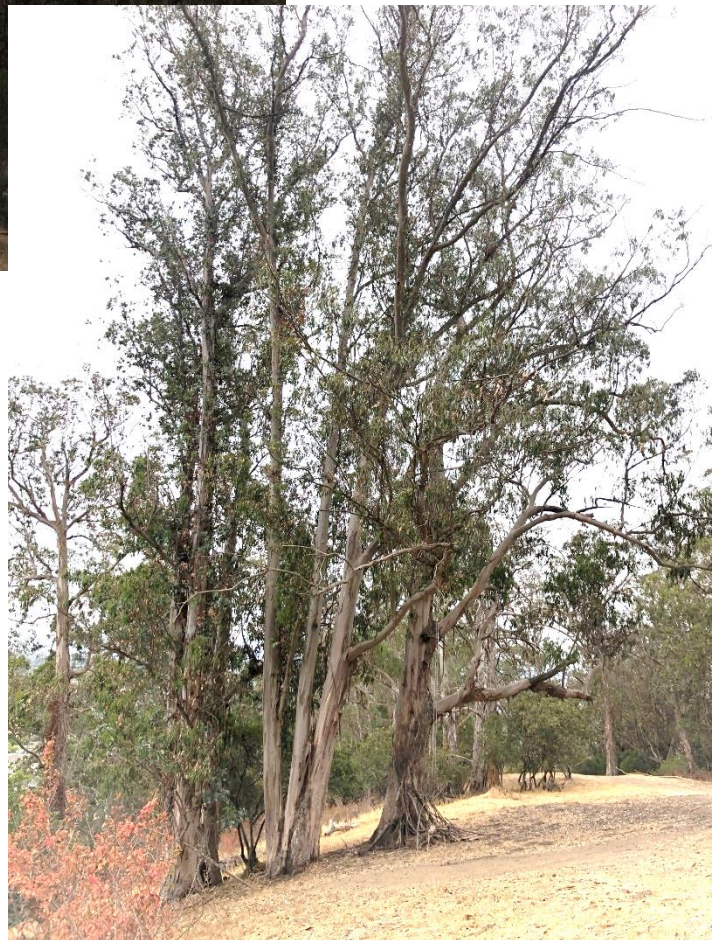
Photo 21. Photo right shows a grouping of trees where retention is possible (if there are no fire scars) due to Live Crown Ratio being a “2” and branch tips still alive. These trees are also located in the Butterfly habitat.

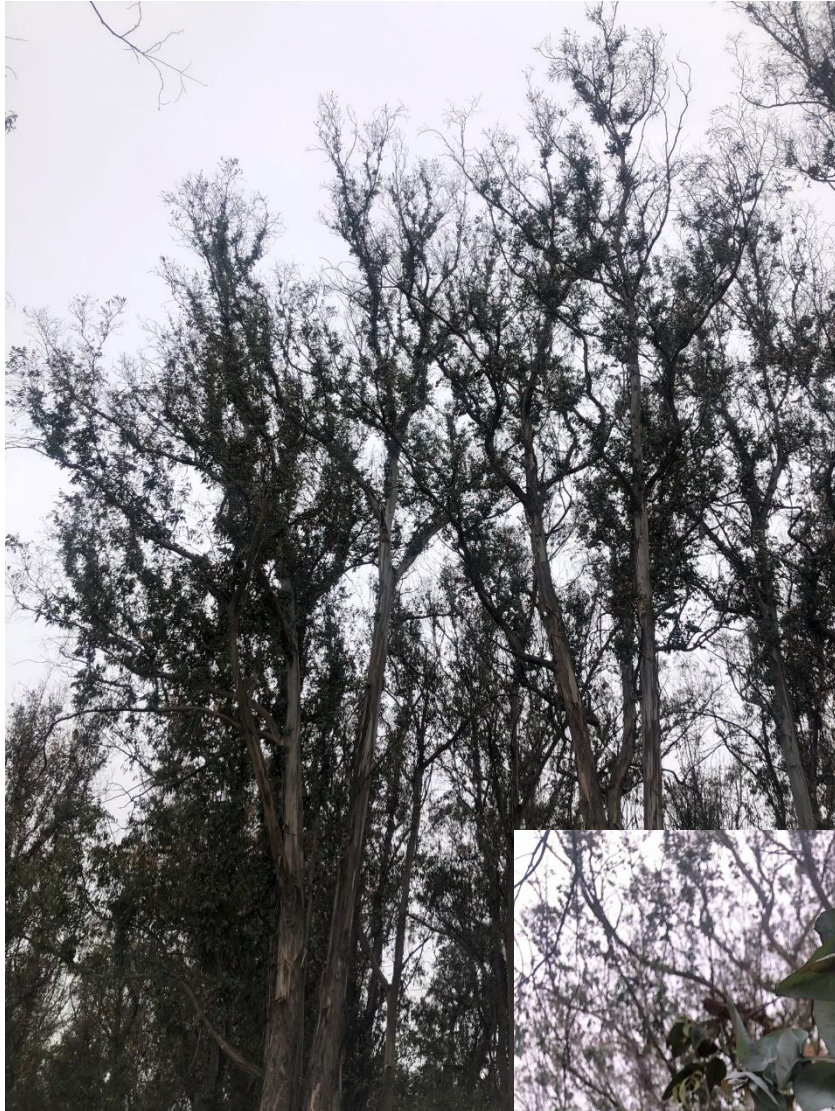
Photo 22. *Photo left shows a grouping of trees in the Butterfly area. All the growth on these trees is juvenile, meaning trees lost all their foliage due to disease and drought had to use carbohydrate storage to produce new leaves. Once carbohydrates are expended, trees often die.*

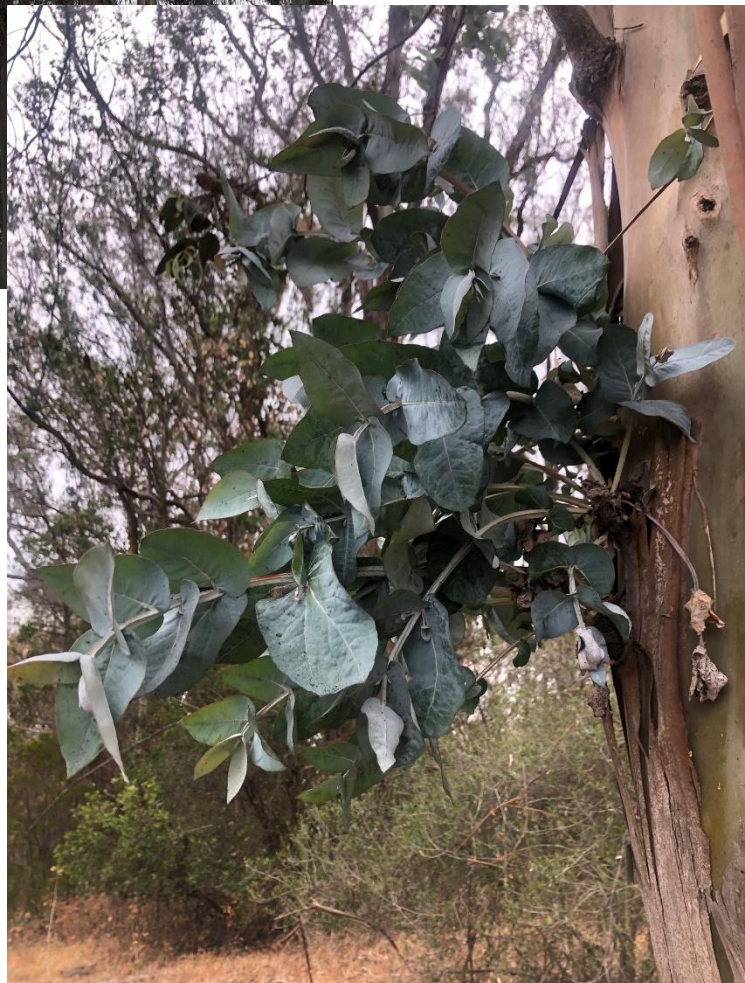
Photo 23. *Photo right shows the juvenile leaves of a Eucalyptus globulus. These appear more bluish than mature leaves, and are positioned opposite on the stem. Mature leaves are alternate.*

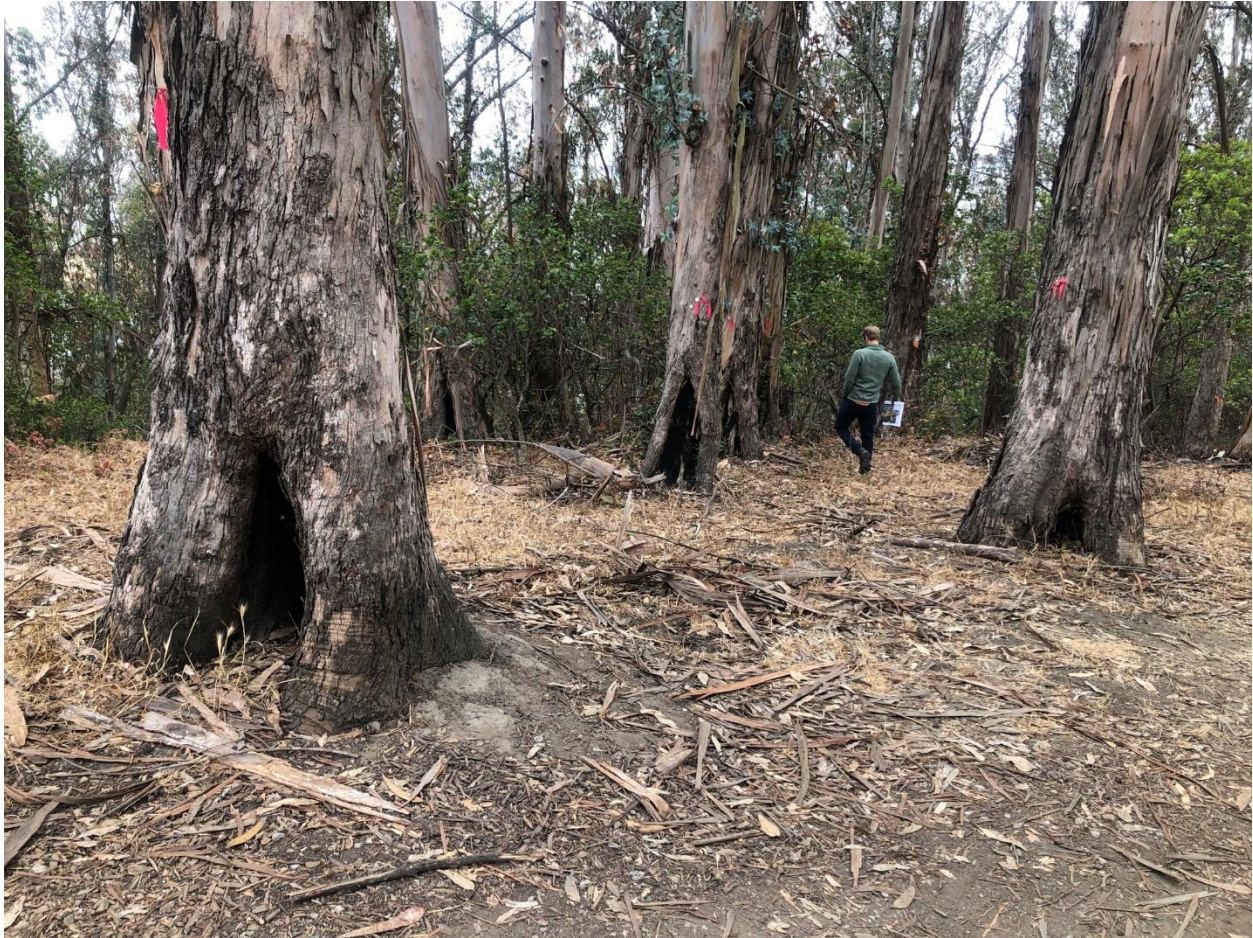
Photo 24. Photo above shows *fire scars on all trees located in the EGHT area at the northwestern end of the park along the trail connecting Taft and Jackson.*
