March 18, 2022

Margot Cunningham
City of Albany Public Works
540 Cleveland Avenue
Albany, CA 94710

Assessment of Tasmanian blue gum trees, *Eucalyptus globulus* in Albany Hill Park

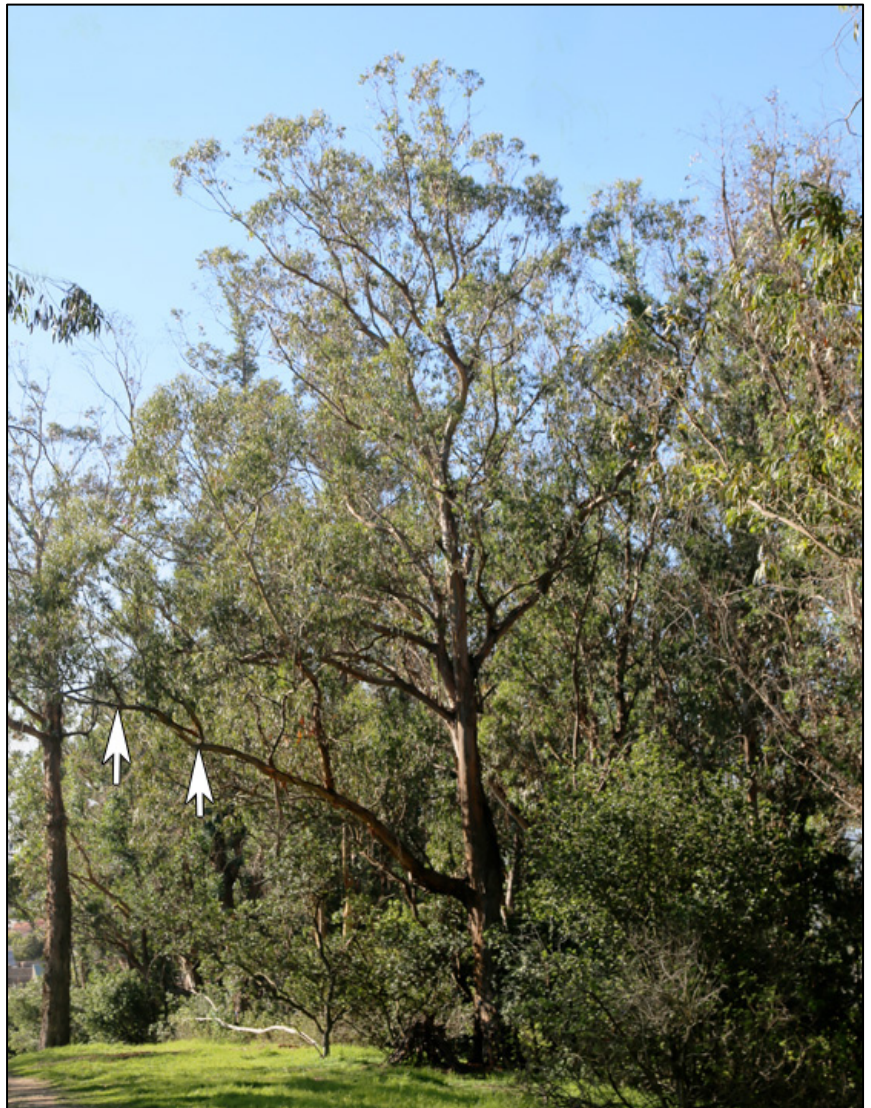
This tree, seen to the right is 49 inches in trunk diameter, measured at 54 inches above ground⁸.

1. The tree is 85 feet tall, but by 28 feet above ground the trunk diameter is half the diameter it is at 54 inches height.
2. At 47 feet, just over half the height of the tree, the trunk diameter is a quarter of the diameter at 54 inches.
3. The Live Crown Ratio, the percentage of height that is covered by limbs extending from the trunk is 85 percent.

These metrics are associated with highly stable trees, resistant to mechanical failure. The mass of the tree is concentrated low, close to the ground. During wind the tree develops minimal momentum, reducing stress on the base and the root system. The regular branching stabilizes the tree through mass damping⁹. In addition, the tree appears more vigorous and healthy than many neighboring Eucalyptus.

One long limb extends east over the path. Consider reducing this limb back to one of the arrows seen to the right, at the discretion of the climber. This will reduce potential for limb failure.

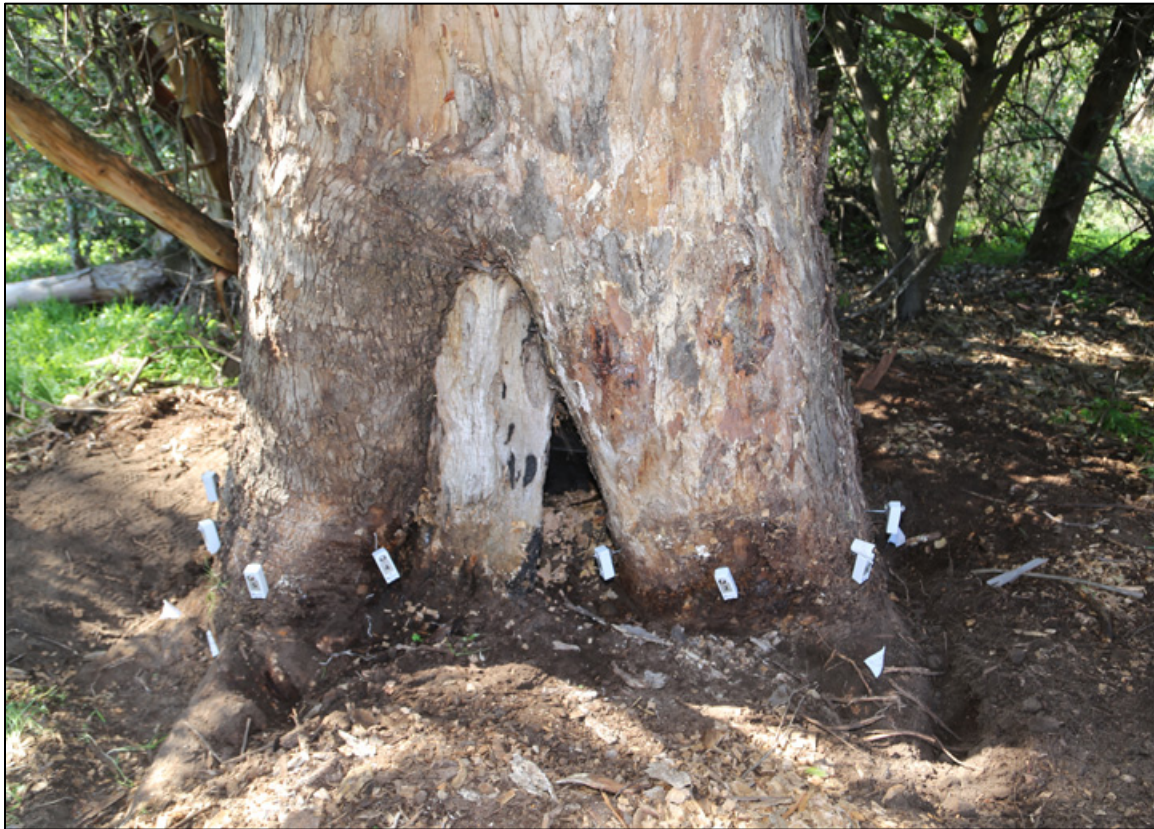
These tree stability attributes are critical for tree #258 because of significant fire injury at the base, with associated decay. In the photo below taken from the northeast a curtain of solid wood covers the left 2/3 of the injury opening, but the wood behind the curtain is decayed.

We tested the tree with the Resistograph at six points in roots, and while we found some decay, the sound portions of the roots are large, robust, and in our opinion capable of supporting the tree, given the stability attributes listed on the previous page.

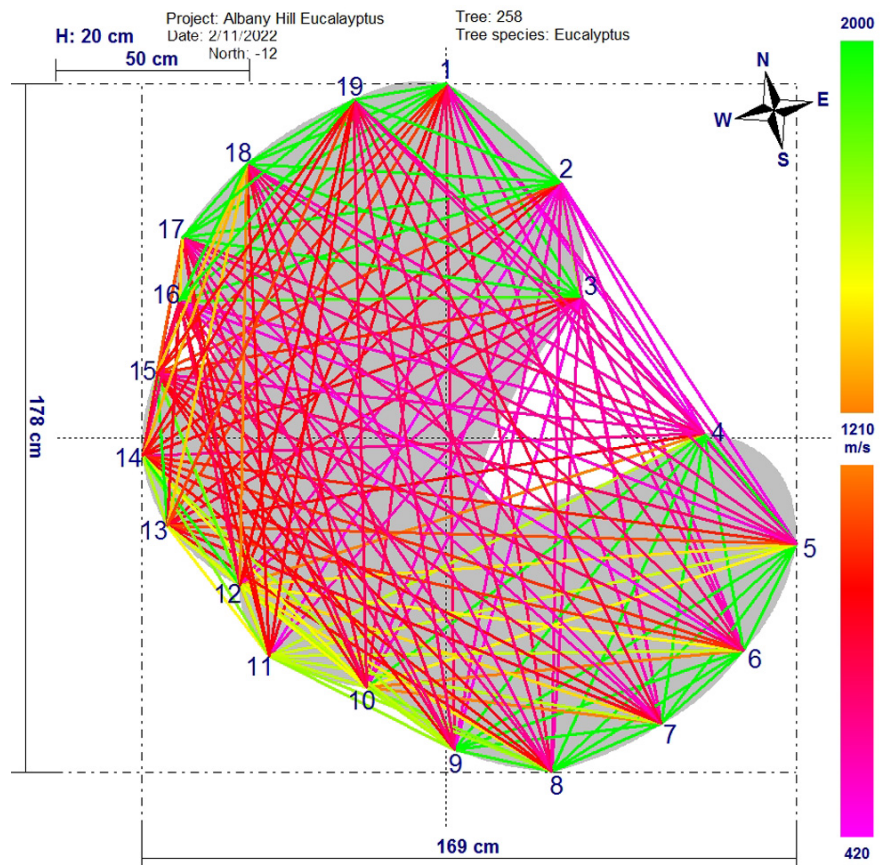
We assessed the tree with the Arbotom at a height of 20 centimeters, or just less than eight inches. One resulting graphic is to the right. Nineteen sensors were attached to the tree. Some are visible in the photo above. Each was tapped, in succession. The instrument measured the speed of the resulting compression wave between each pair of sensors. That speed is represented on the graphic by the color code at the right. The speed ranges from 420 meters/second to 2000 meters/second. A slow speed implies the signal, the compression wave must travel around a defect in the

tree, an area of low density due to decay, or a cavity.

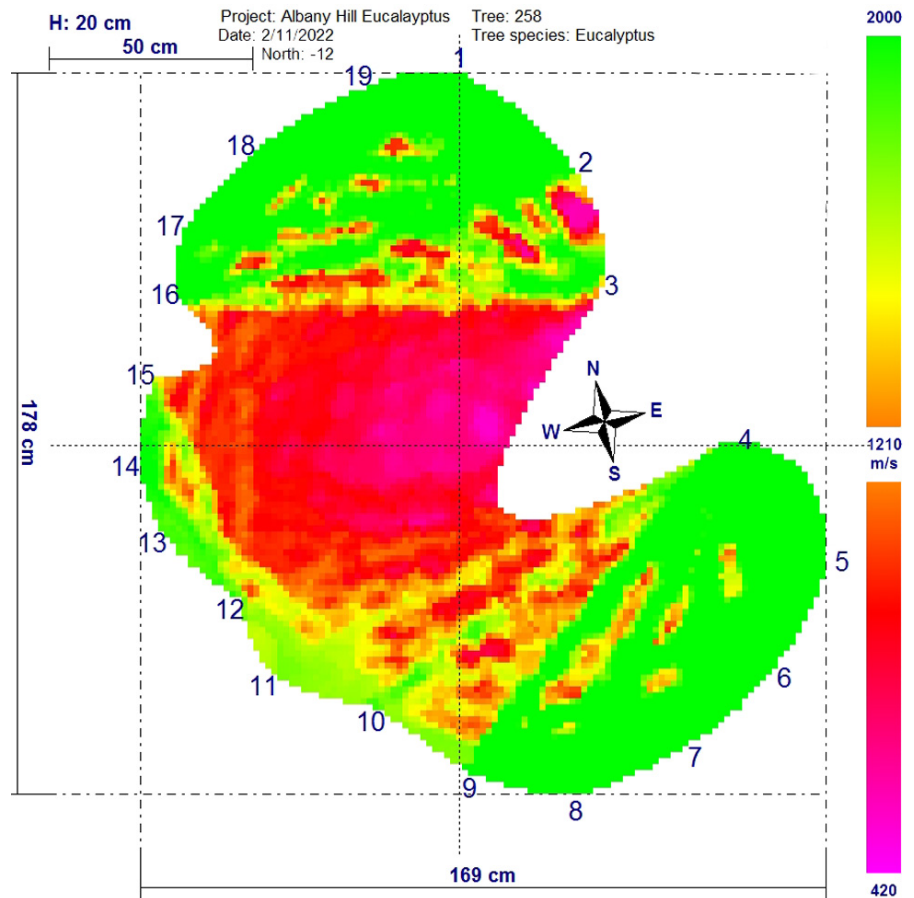
The upper graphic to the right has converted the graphic on the previous page to a surface-coded graph. Wood density is represented by color.

In our opinion the tree is more stable than might initially appear from seeing this graphic. The lower image is the result of mechanical calculations that suggest the tree trunk has lost about 23 percent of its strength across the trunk at 20 centimeters height, a location likely to be most critical, as the nexus of strength impairment due to injury or decay, and stress from wind loading above. All else held equal, the tree is least strong to the northeast, the direction in which it has lost 23 percent capacity.

However, the extreme taper of the trunk and limbs of the tree combined with the large trunk diameter relative to height and the favorable Live Crown Ratio more than buffer the tree against this strength loss, in our opinion.

It is our opinion this tree is stable against whole tree failure for at least the next five years. We suggest pruning dead limbs of two inch or larger diameter from the east side of the tree, where their failure could endanger persons on the trail.

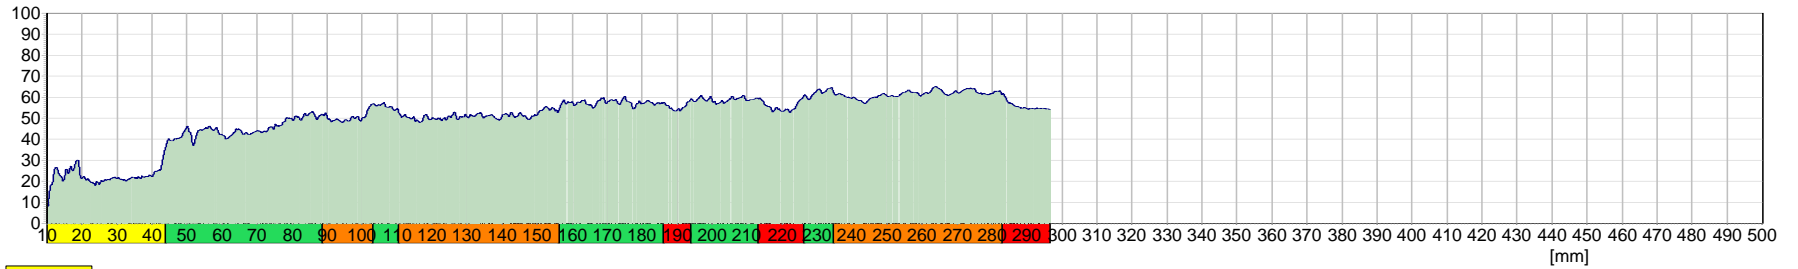
01560001 20220210 Albany Hill, Tree 156 Profile #1
Mixed sound with decay, functionally sound

- Bark & Sapwood (12%)
- Early stage decay (38%)
- Advanced decay (12%)
- Sound (38%)

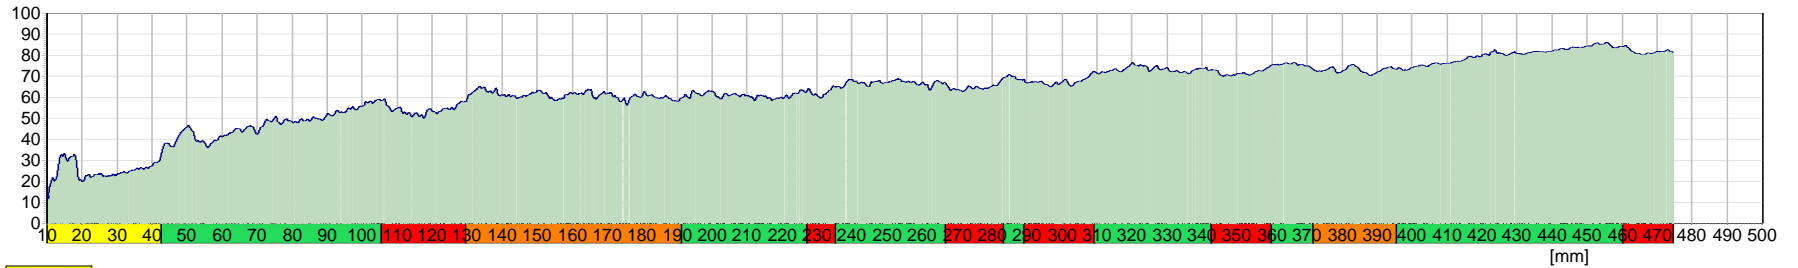
01560002 20220210 Albany Hill Tree #156 Profile #2
Mixed sound with decay, functionally sound

- Bark & Sapwood (7%)
- Early stage decay (18%)
- Advanced decay (22%)
- Sound (53%)

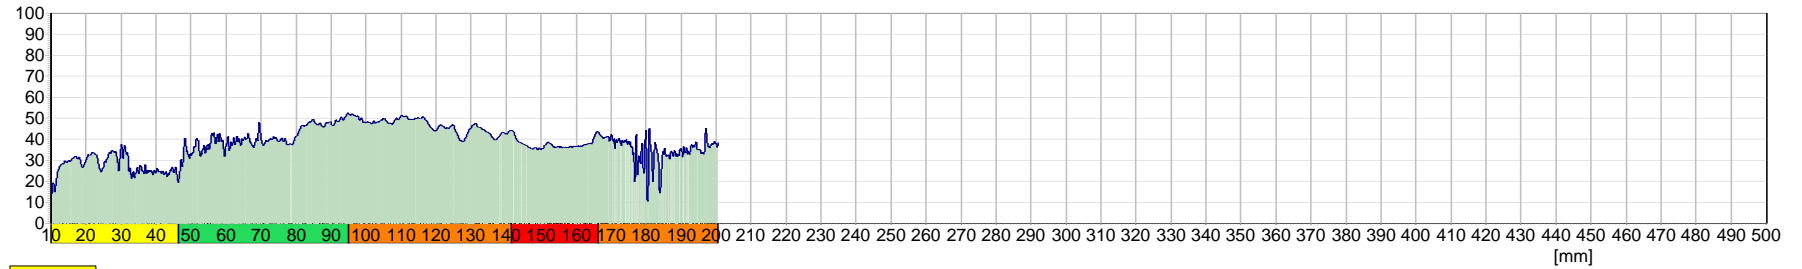
02280001 20220210 Albany Hill Tree 228 Profile #1
Mixed decay states past about 9.5 cm

- Bark & Sapwood (19%)
- Early stage decay (42%)
- Advanced decay (13%)
- Sound (26%)

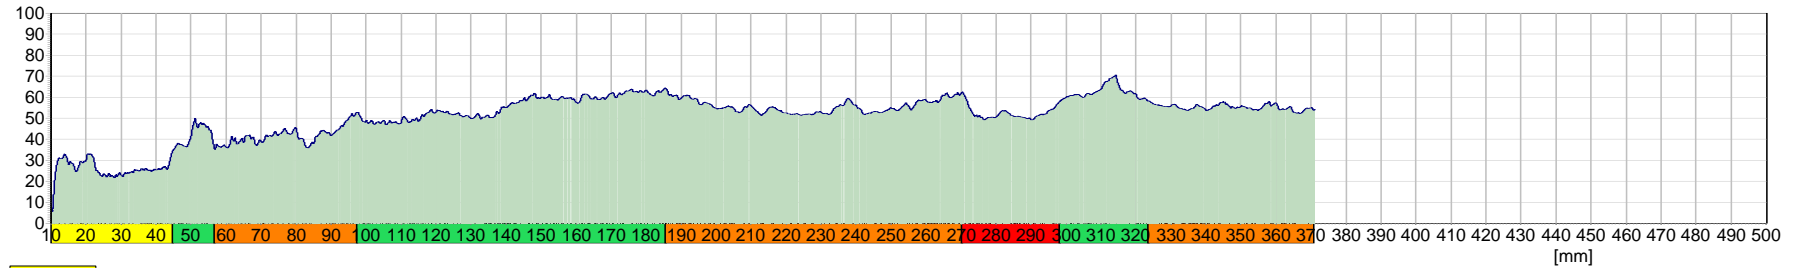
02280002 20220210 Albany Hill Tree 228 Profile #2
Mixed sound with decay states

- Bark & Sapwood (10%)
- Early stage decay (48%)
- Advanced decay (8%)
- Sound (35%)

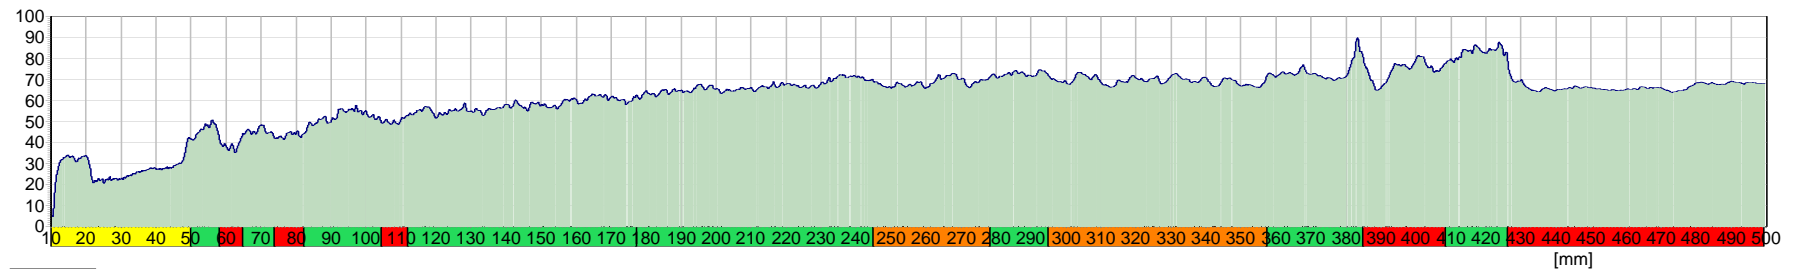
02280003 20220210 Albany Hill Tree 228 Profile #3
Mixed sound with decay, functionally sound

- Bark & Sapwood (8%)
- Early stage decay (20%)
- Advanced decay (24%)
- Sound (48%)

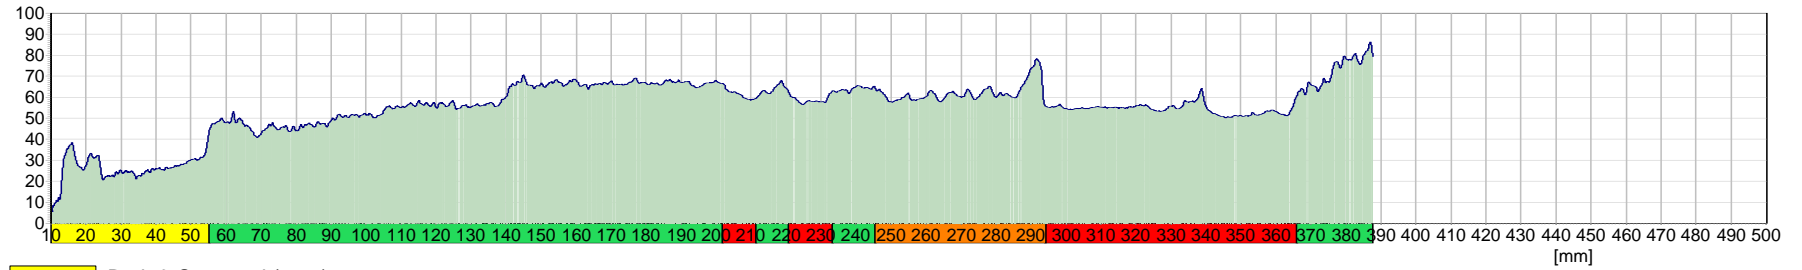
02280004 20220210 Albany Hill Tree 228 Profile #4
Mixed sound with decay, functionally sound given location in the tree

- Bark & Sapwood (12%)
- Early stage decay (13%)
- Advanced decay (25%)
- Sound (50%)

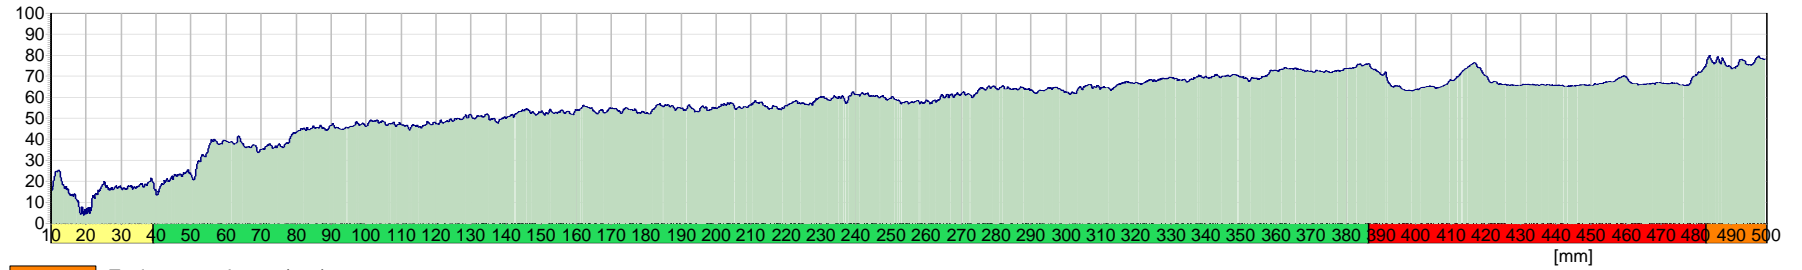
02580004 20220211 Albany Hill Tree 258 Profile #4
Sufficiently sound

- Early stage decay (3%)
- Advanced decay (19%)
- Sound (69%)
- Bark (8%)

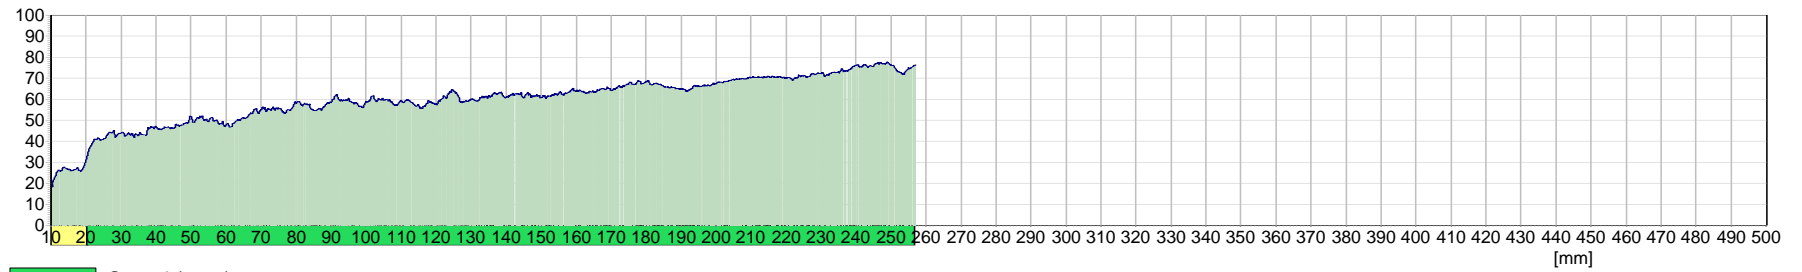
02580005 20220211 Albany Hill Tree 258 Profile #5, in root
Sound

- Sound (92%)
- Bark (8%)

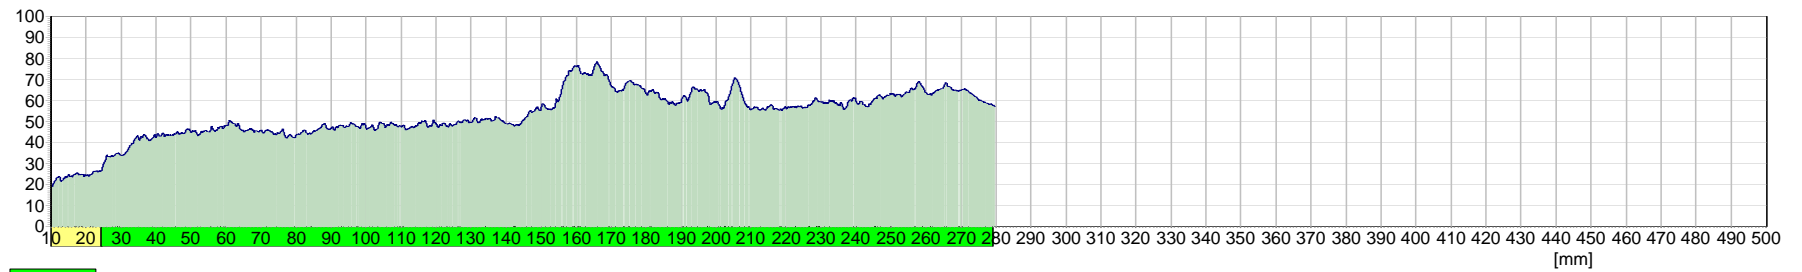
02580006 20220211 Albany Hill Tree 258 Profile #6 in root
Sound

- intact (91%)
- Bark (9%)

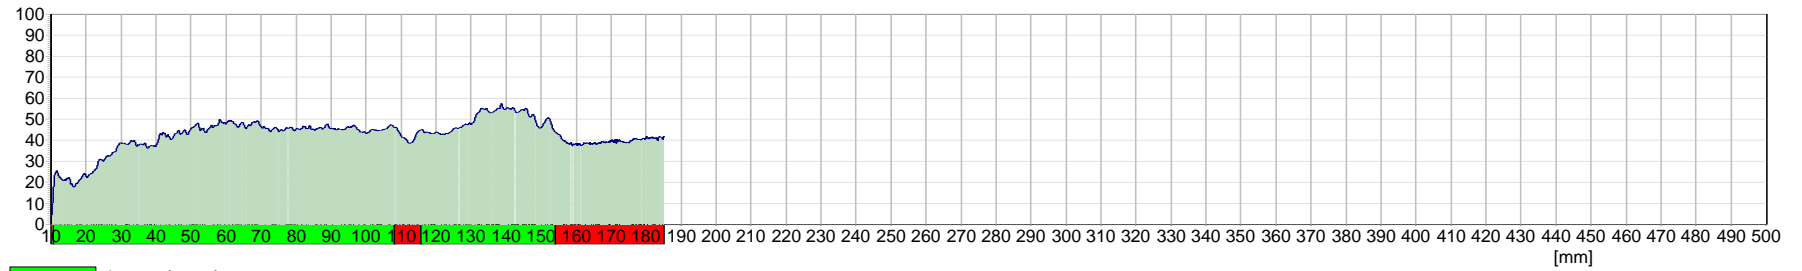
03890001 20220210 Albany Hill Tree 389 Profile #1
Sound as expected, in all new tissues outside the old stump

- intact (74%)
- decayed (21%)
- Bark (6%)
