Arborist Report

ALBANY HILL EUCALYPTUS TREE SURVEY

DATE: July 23, 2021

SBCA TREE CONSULTING

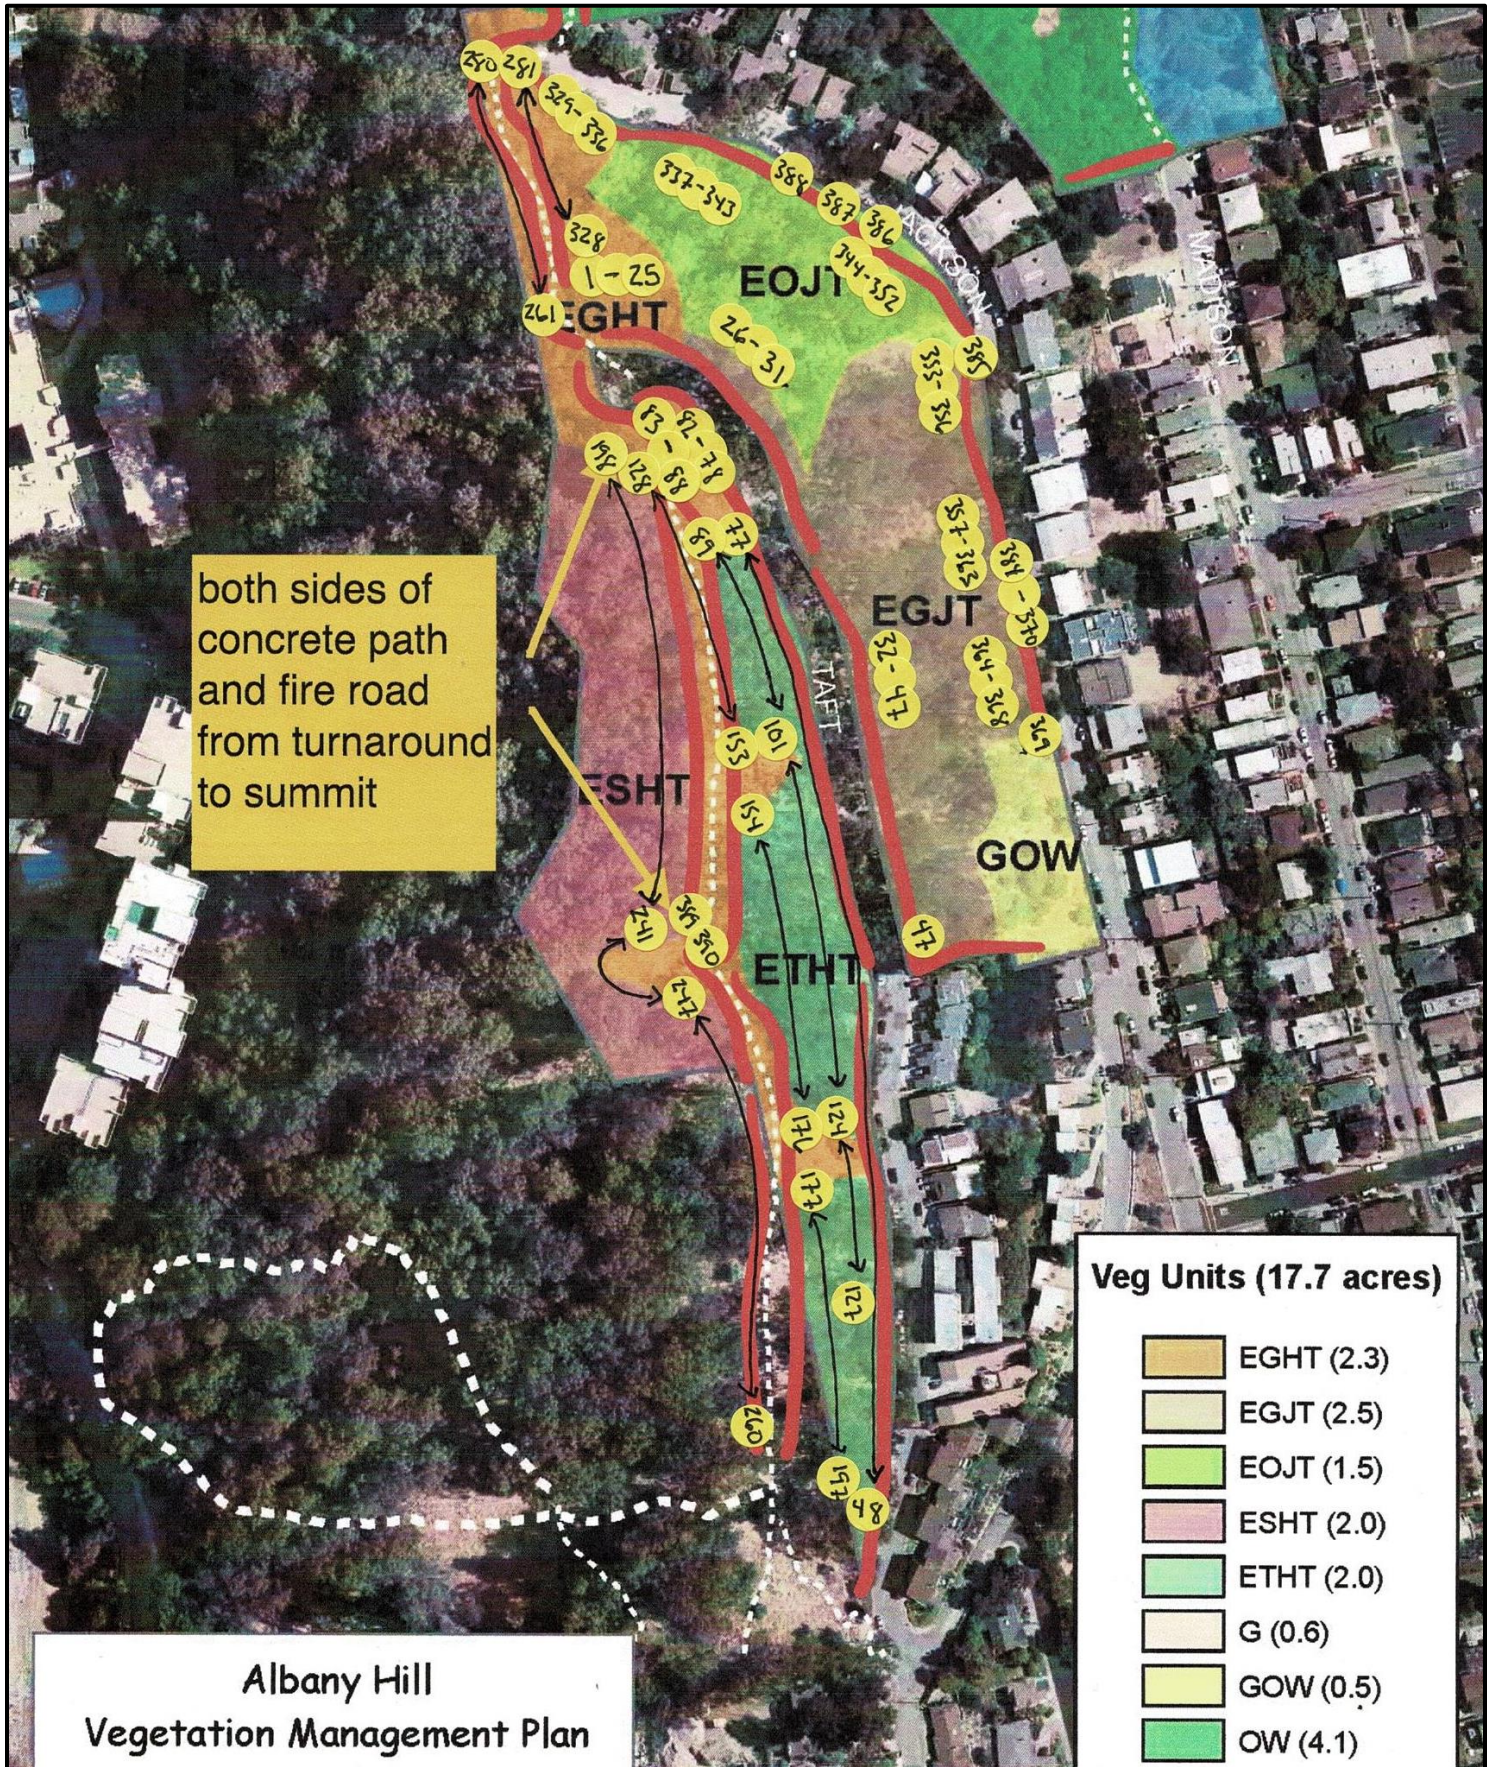
Photo 1. Photo above shows the tops of the Eucalyptus located in the EGHT area at the northwestern end of the park. Trees in this area were observed to be in the worst condition, with significant fire scars, dead tops, and live crown ratios less than 10%.
