March 18, 2022

Margot Cunningham
City of Albany Public Works
540 Cleveland Avenue
Albany, CA 94710

Assessment of Tasmanian blue gum trees, *Eucalyptus globulus* in Albany Hill Park

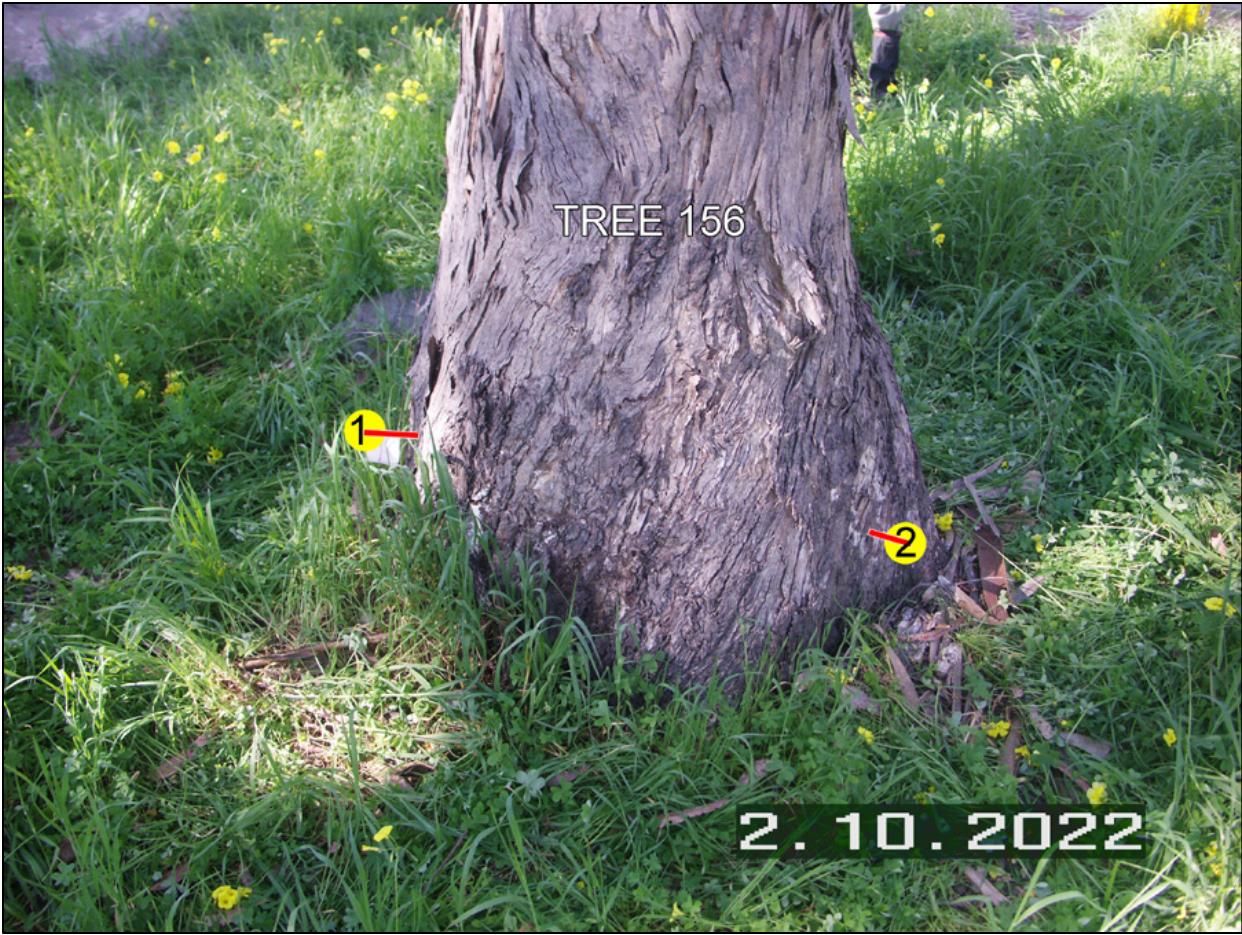
APPENDIX IV PHOTO KEY OF RESISTOGRAPH LOCATIONS, TREE #156

01560001 20220210 Albany Hill, Tree 156 Profile #1
Mixed sound with decay, functionally sound

- Bark & Sapwood (12%)
- Early stage decay (38%)
- Advanced decay (12%)
- Sound (38%)

01560002 20220210 Albany Hill Tree #156 Profile #2
Mixed sound with decay, functionally sound

- Bark & Sapwood (7%)
- Early stage decay (18%)
- Advanced decay (22%)
- Sound (53%)

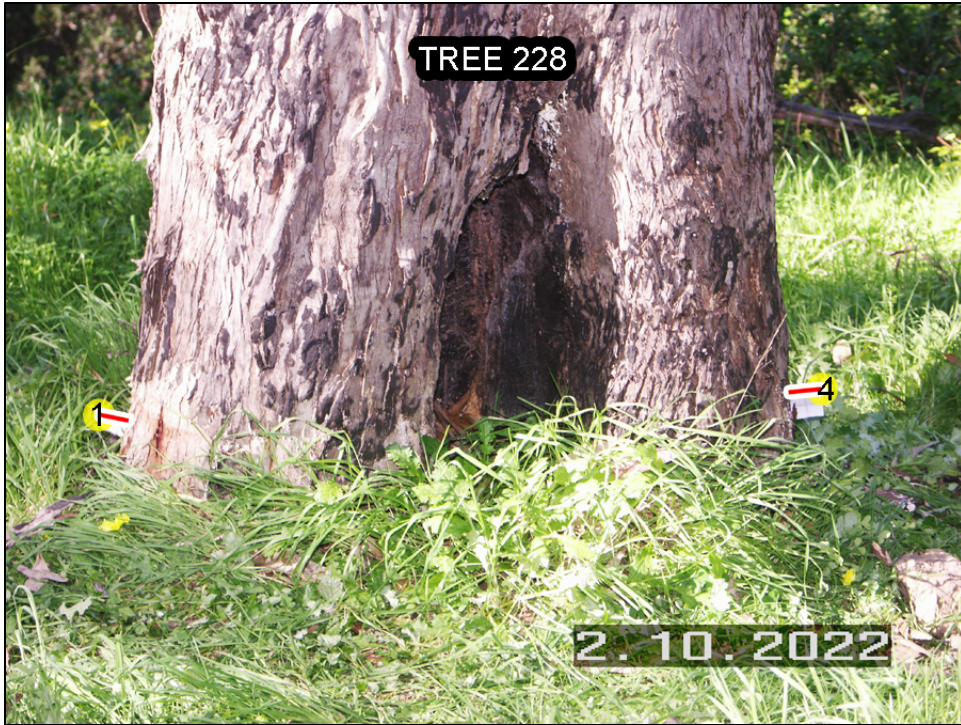
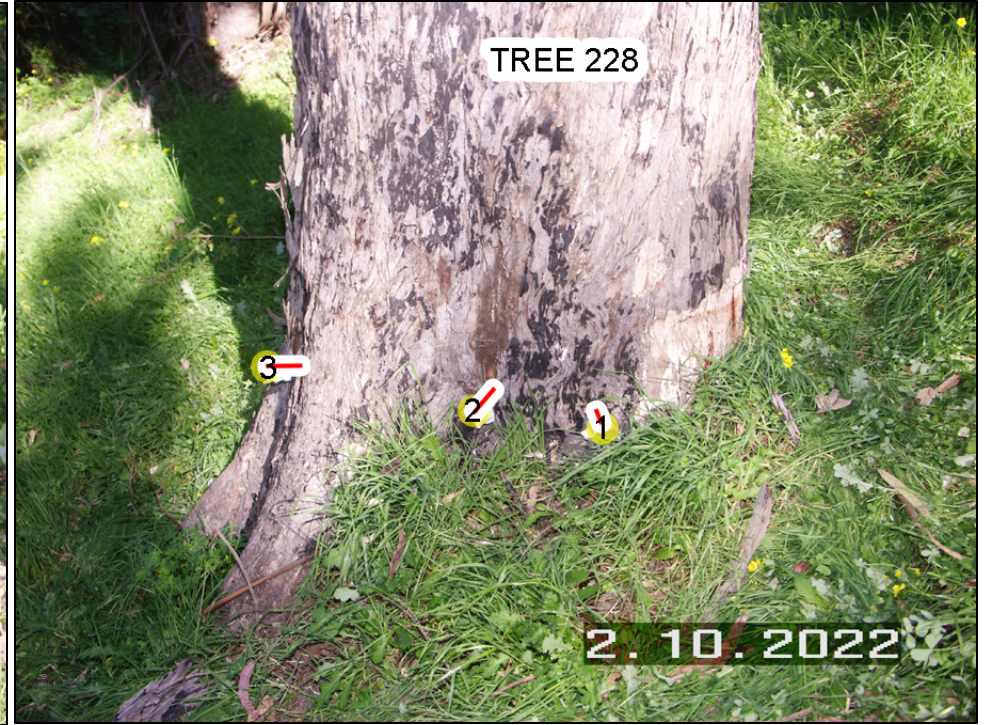
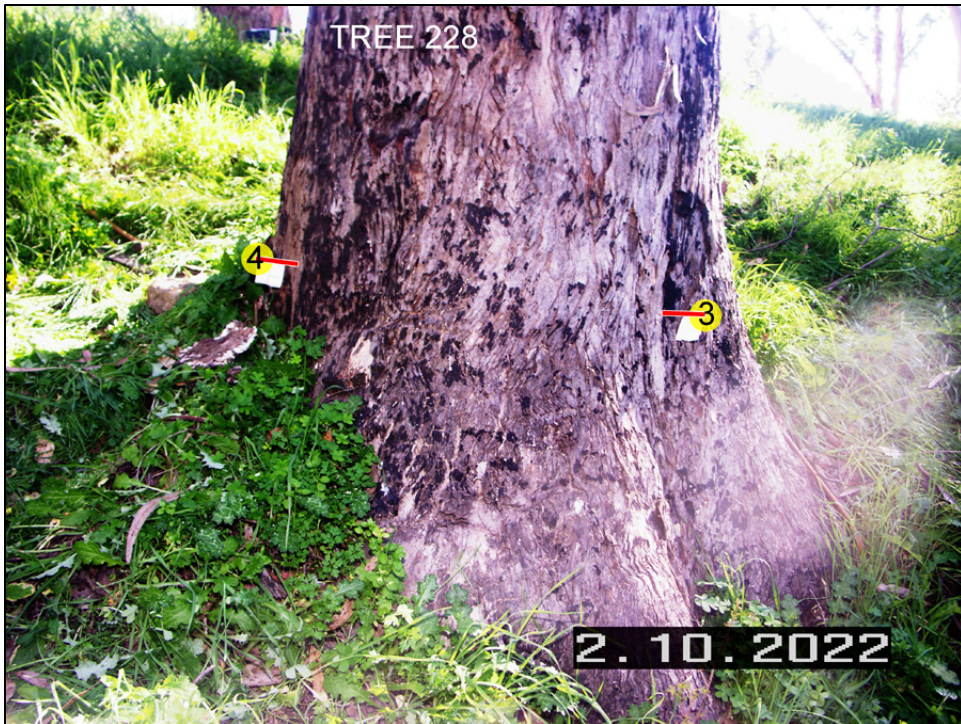
APPENDIX IV PHOTO KEY OF RESISTOGRAPH LOCATIONS, TREE #228

02280001 20220210 Albany Hill Tree 228 Profile #1
Mixed decay states past about 9.5 cm

- Bark & Sapwood (19%)
- Early stage decay (42%)
- Advanced decay (13%)
- Sound (26%)

02280002 20220210 Albany Hill Tree 228 Profile #2
Mixed sound with decay states

- Bark & Sapwood (10%)
- Early stage decay (48%)
- Advanced decay (8%)
- Sound (35%)

02280003 20220210 Albany Hill Tree 228 Profile #3
Mixed sound with decay, functionally sound

- Bark & Sapwood (8%)
- Early stage decay (20%)
- Advanced decay (24%)
- Sound (48%)

02280004 20220210 Albany Hill Tree 228 Profile #4
Mixed sound with decay, functionally sound given location in the tree

- Bark & Sapwood (12%)
- Early stage decay (13%)
- Advanced decay (25%)
- Sound (50%)

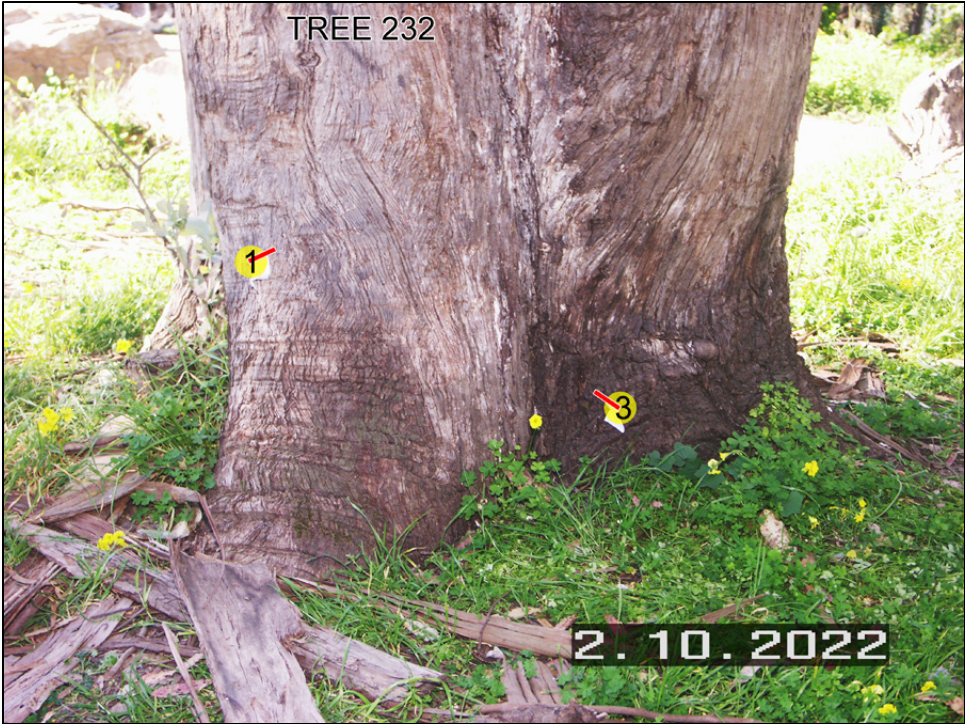
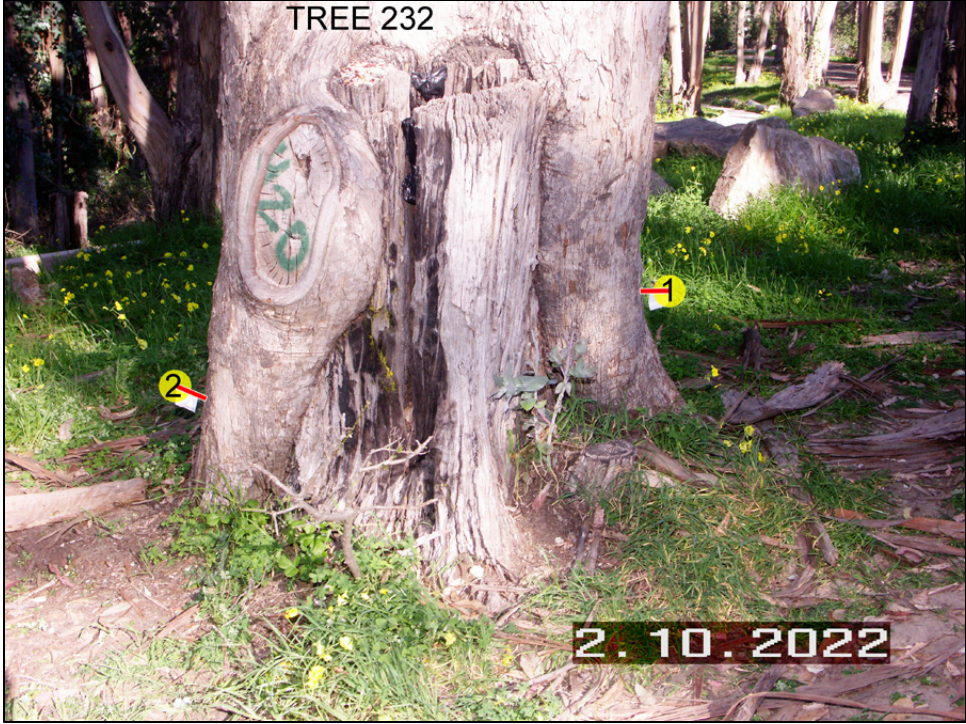
APPENDIX IV PHOTO KEY OF RESISTOGRAPH LOCATIONS, TREE #232

02320001 20220210 Albany Hill Tree 232 Profile #1
Sound

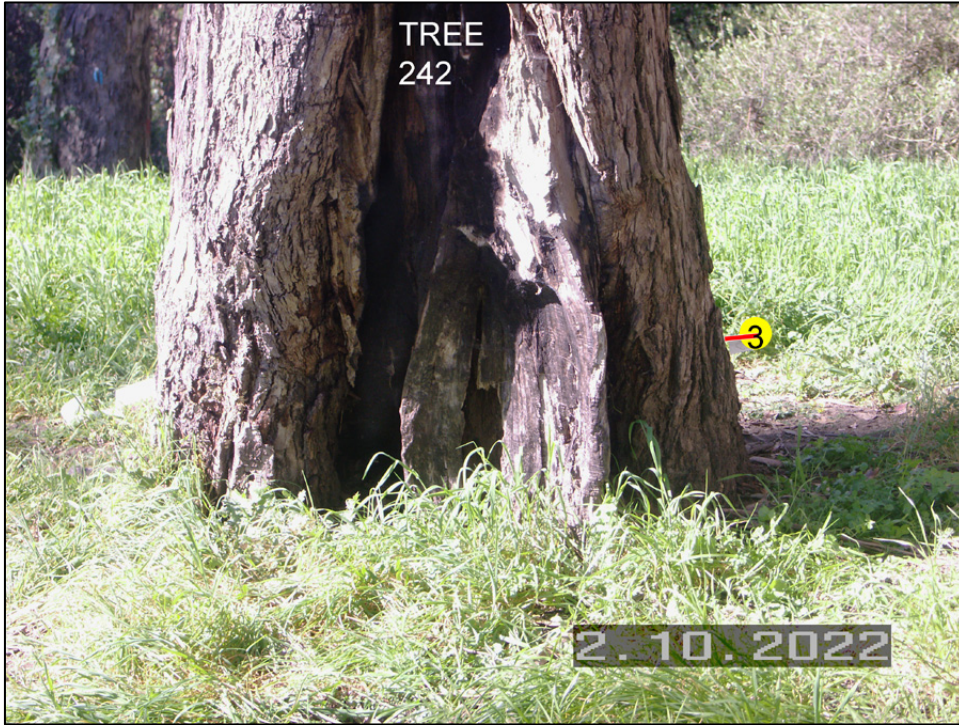
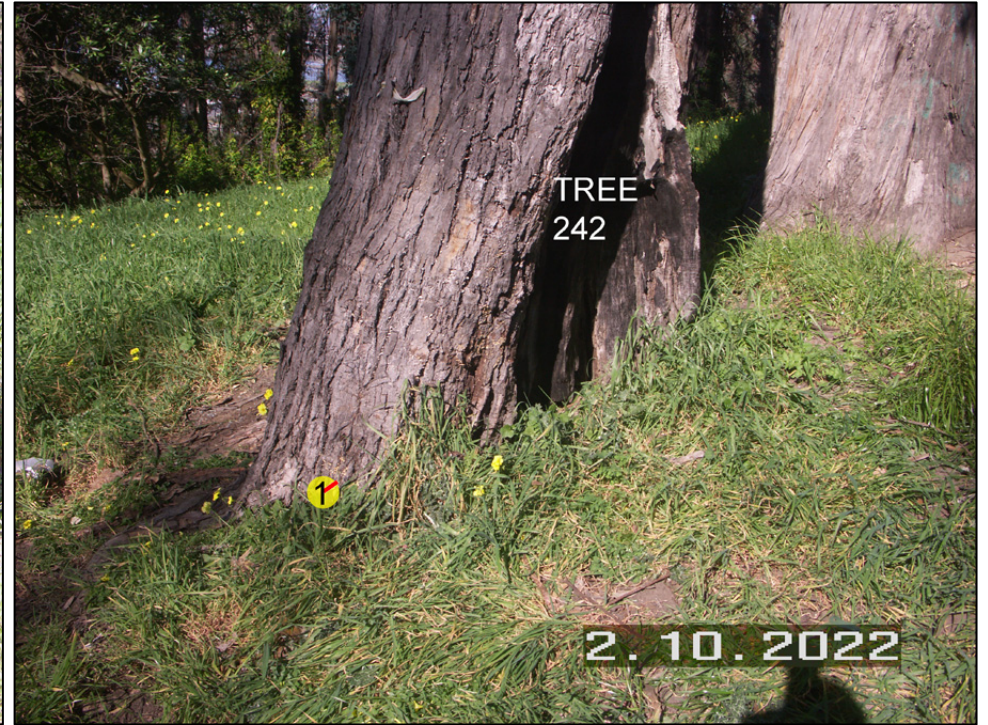
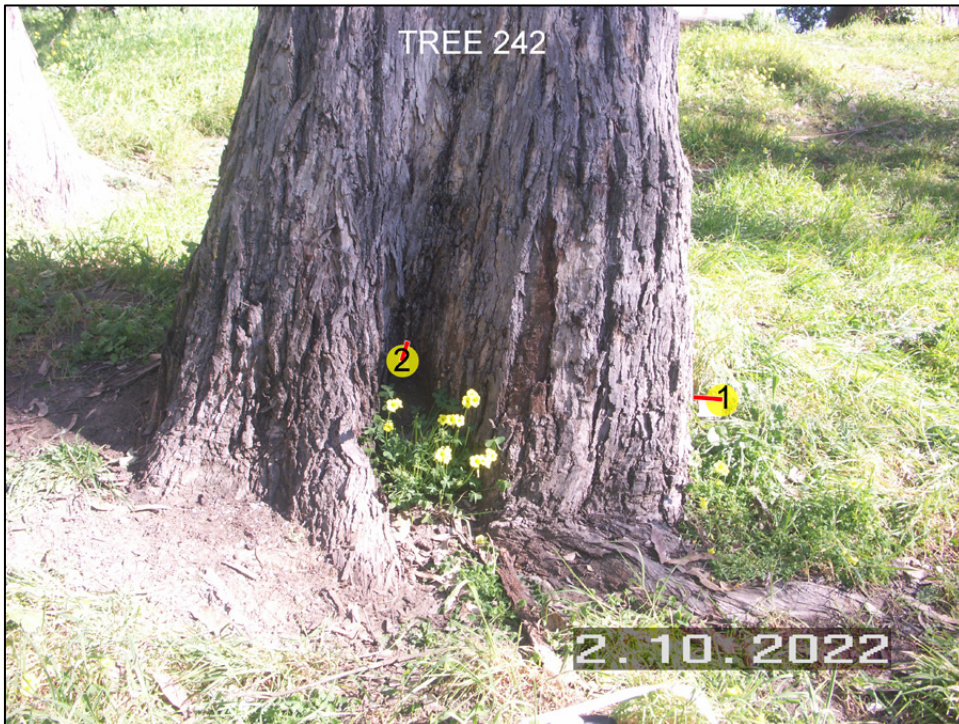
APPENDIX IV PHOTO KEY OF RESISTOGRAPH LOCATIONS, TREE #242

02420001 20220210 Albany Hill Tree 242 Profile #1
 Sound to 24 cm, sufficient

02420002 20220210 Albany Hill Tree 242 Profile #2
 Sound to 15 cm in fissured zone opposite open wound, sufficient

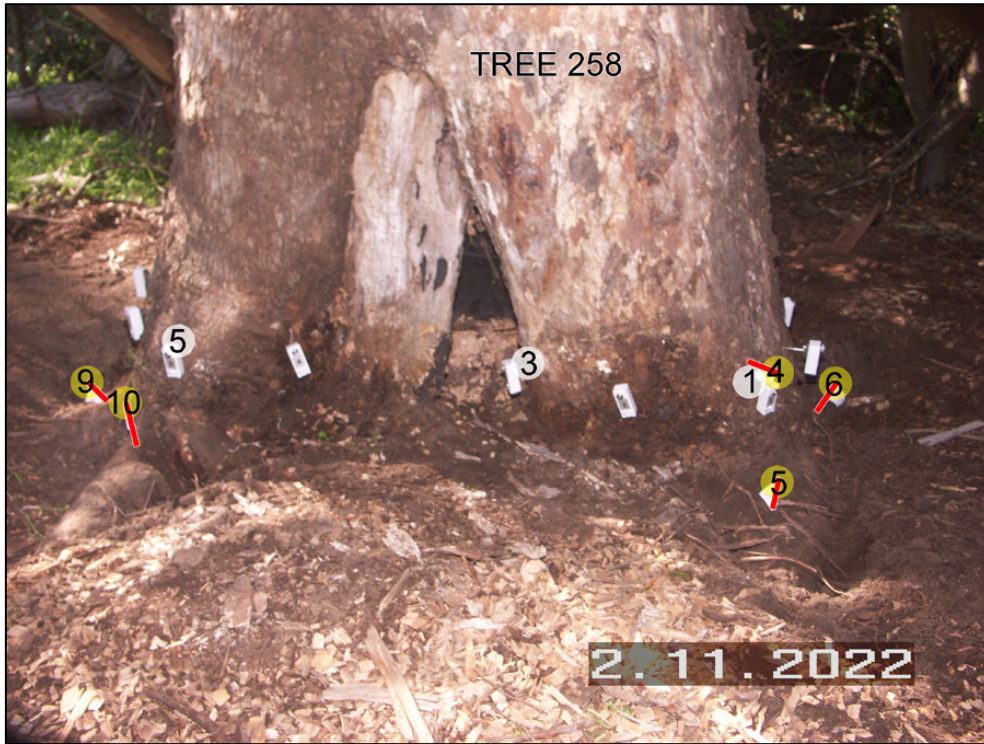
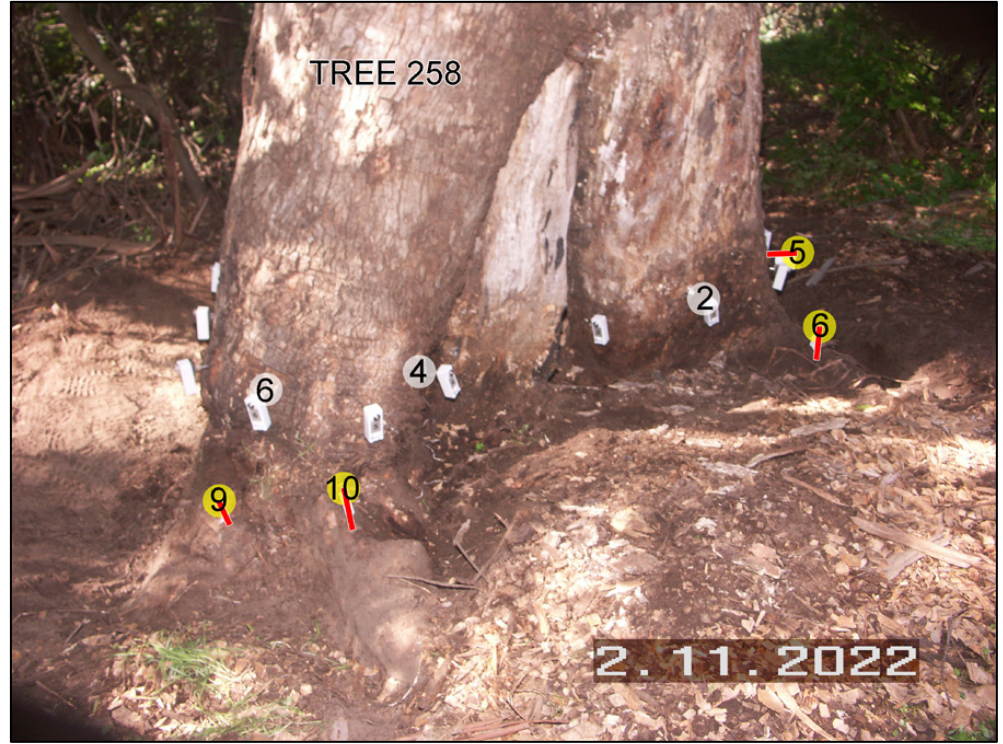
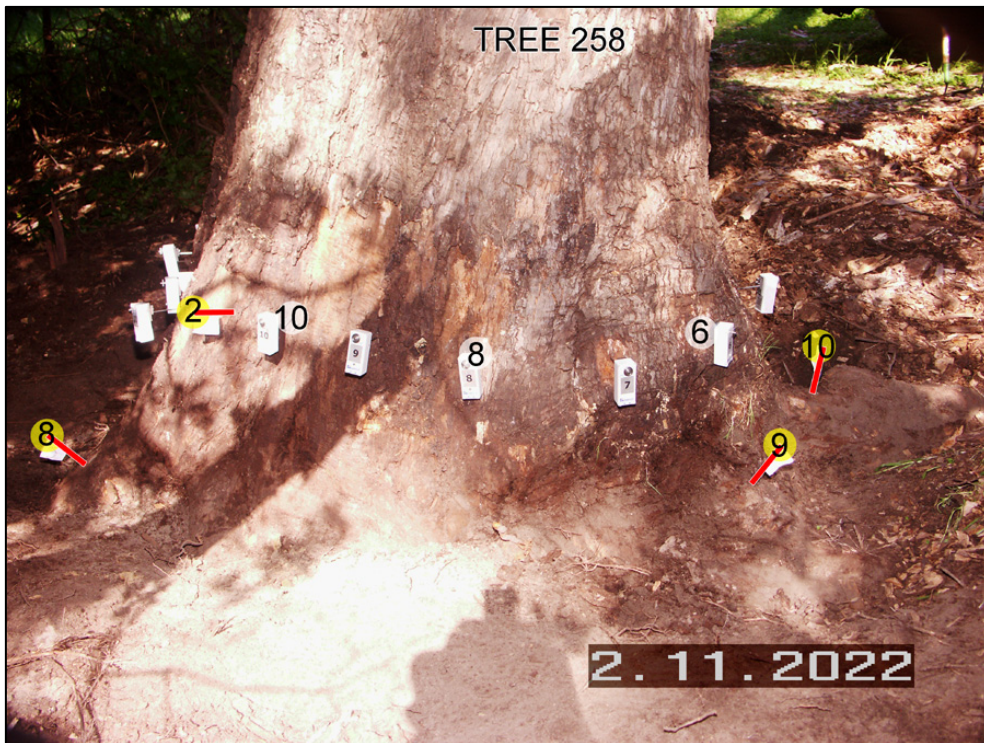
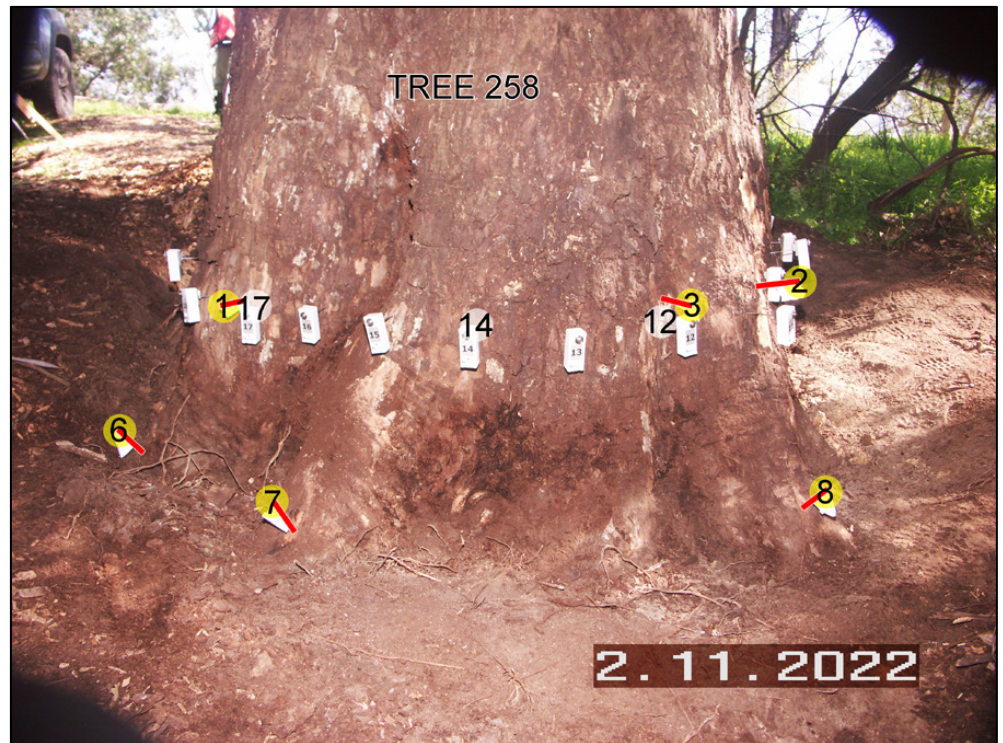
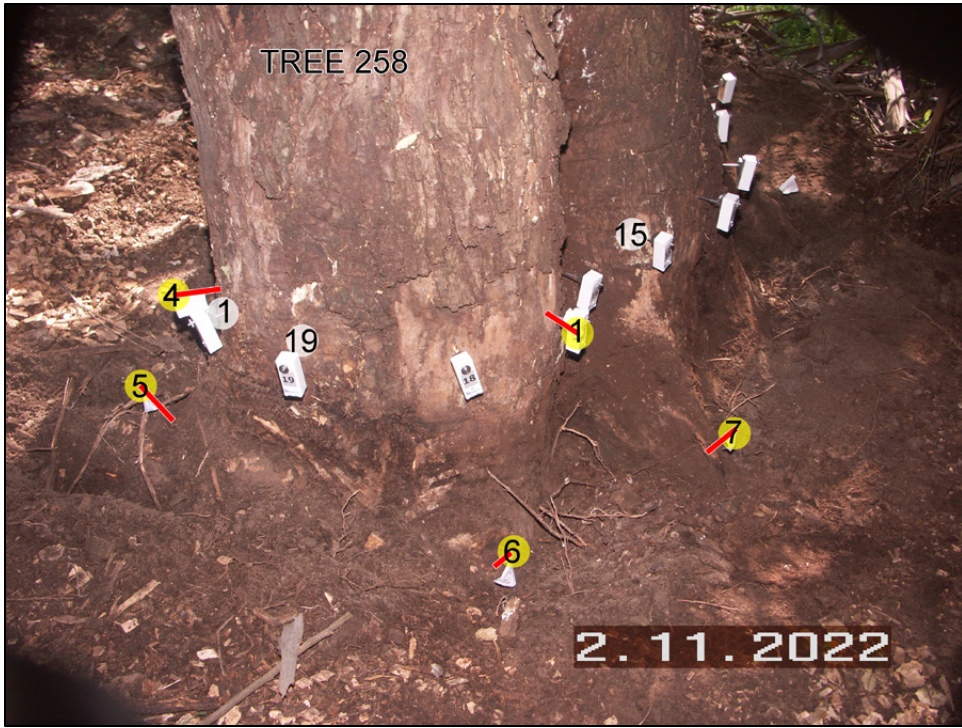
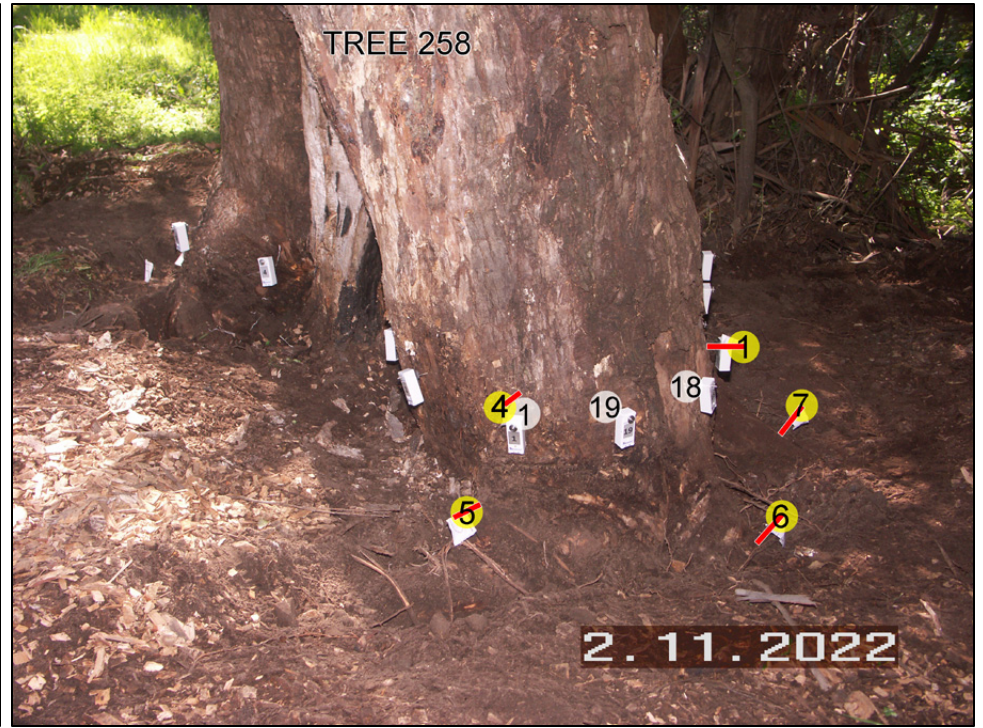
APPENDIX IV PHOTO KEY OF RESISTOGRAPH/TOMOGRAPH LOCATIONS, TREE #258

We concur with the management recommendations of SBCA Tree Consulting, with the exception of the removal of tree #258¹. This tree is at the southern edge of the surveyed trees, and is a well-structured tree that remains in good health. We tested this tree, and in

02580001 20220211 Albany Hill, Tree #258 Profile 1, by Arbortom Sensor 17
Functionally sound

- Early stage decay (3%)
- Advanced decay (19%)
- Sound (69%)
- Bark (8%)

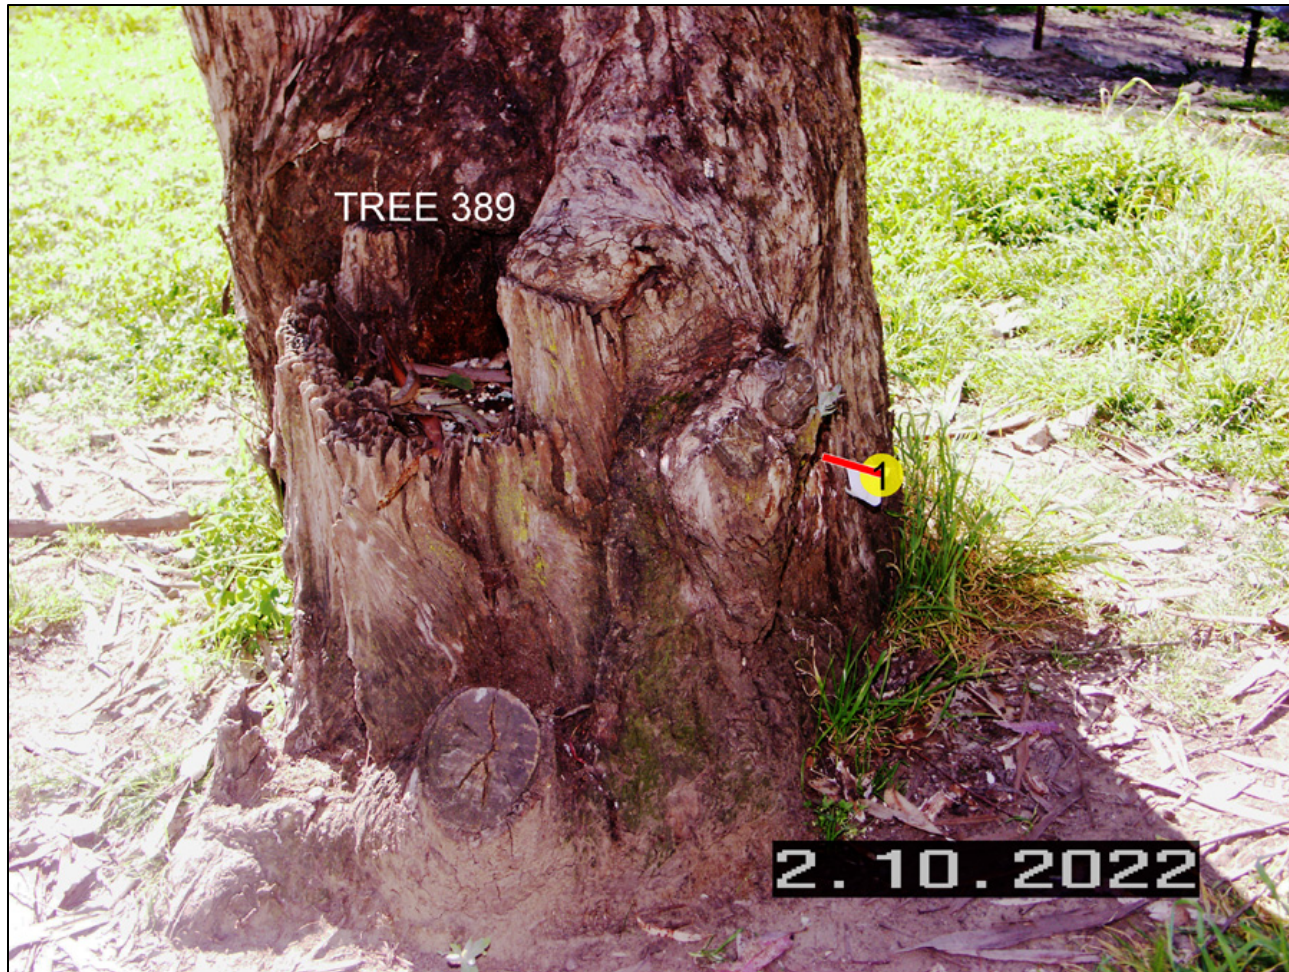
APPENDIX IV PHOTO KEY OF RESISTOGRAPH LOCATIONS, TREE #389

03890001 20220210 Albany Hill Tree 389 Profile #1
Sound as expected, in all new tissues outside the old stump

- intact (74%)
- decayed (21%)
- Bark (6%)

389	Improbable	Remove	X		Removal accomplishes clearing the area for replanting
390	Improbable	Remove			Will be orphaned, exposed if 241 and 242 are removed. One of two trunks of this tree is poorly attached. Removal of 390 will preclude risk from newly exposed tree.

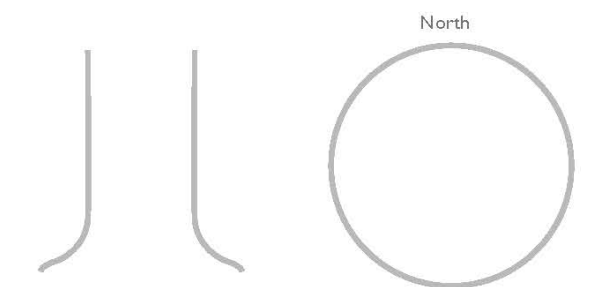
Limb and root failure assessment were not included. The above is an illustration that increased that wind exposure accompanying removal of surrounding trees will increase the likelihood of failure of tree #174 from Possible to Probable, increasing Likelihood of impact to Somewhat Likely, and Risk to Moderate
